# TECHNICAL PROCEDURE

## ULTRAA-K™ SLIDER SUSPENSION

**SUBJECT:** Pivot Alignment Slot Repair Kit  
Installation Procedures

**LIT NO:** T82003

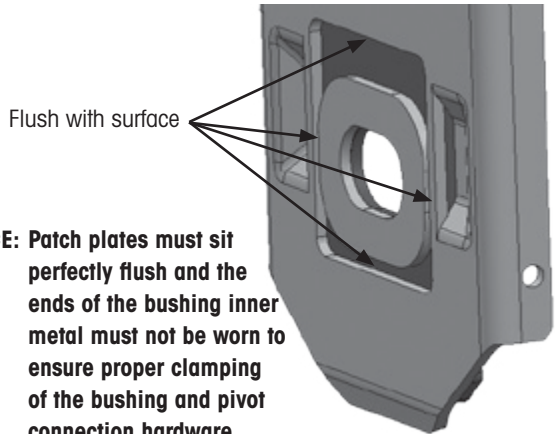
Figure 5: Patch plate flush against frame bracket (back side of outboard plate shown)

**NOTICE:** Patch plates must sit perfectly flush and the ends of the bushing inner metal must not be worn to ensure proper clamping of the bushing and pivot connection hardware.

3. Temporarily place the applicable patch plate, inner and outer, in the cutouts to check for proper placement and fit, Figure 5, Figure 6 and Figure 8.
4. If edges of cutout interfere with the placement of the patch plate, enlarge the cutout as needed.
5. Repeat the above steps until all of the below criteria is met for each repair location.

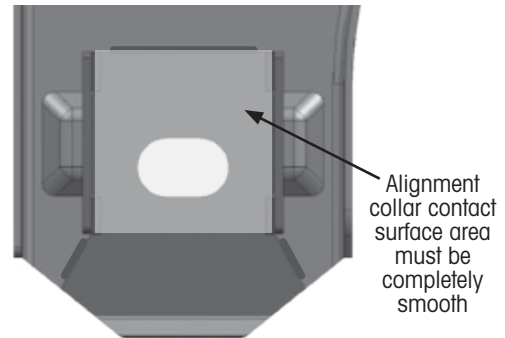
Figure 10: Alignment collar contact surface area

**⚠ WARNING:** If not completely smooth, any burrs or misalignment of the newly installed repair can interfere with bushing inner metal and alignment collar placement. This can result in an improper clamping of the pivot connection hardware.

1. **Smooth** the surface on the patch plates to remove all weld spatter where the collars contact the surface, Figure 10.

**NOTICE:** Avoid removal of parent material.
