H TECHNICAL BULLETIN

VANTRAAX® HEIGHT CONTROL VALVE (HCV)

SUBJECT: Linkage Installation Tips

LIT NO: T89001

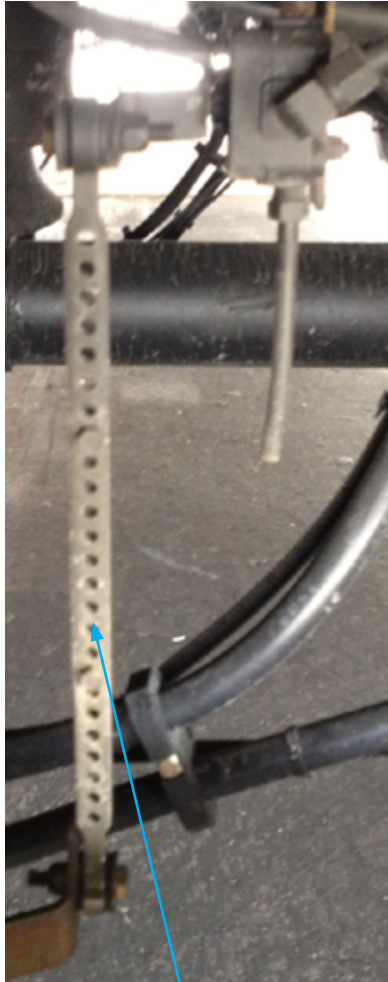
Correctly installed linkage

Linkage positioned vertically.

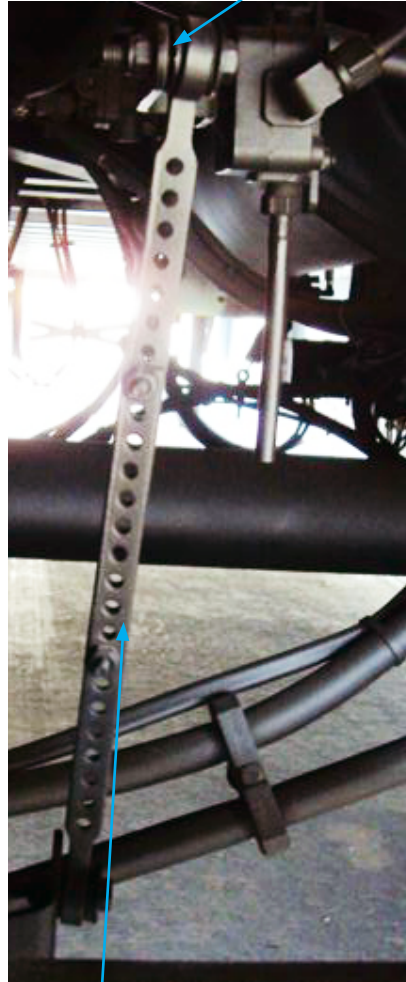
Linkage mounted on wrong side of HCV lever
(bolt in wrong direction)

Linkage positioned non-vertical.
Do not add lean or twist to linkage.

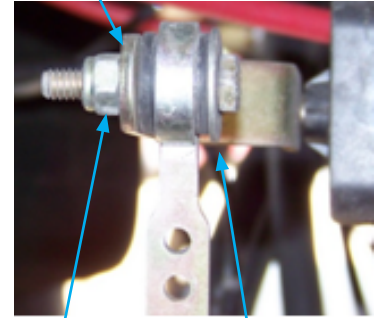
Washer must be free to spin

Lock nut must not compress bushing and connection.

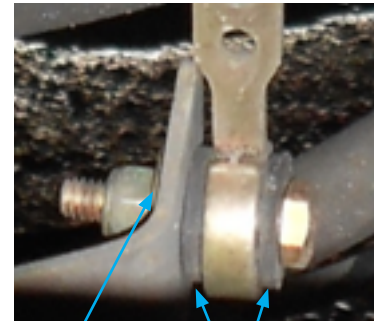
Washer should be at bolt head

Connection is too tight and restricted.
Rubber bushing is compressed.
