H SALES ENGINEERING UPDATE

NO: SEU-9802

SUBJECT: HN-402/462 Auxiliary Spring Assembly

EFFECTIVE DATE: August 1998 REVISION: A

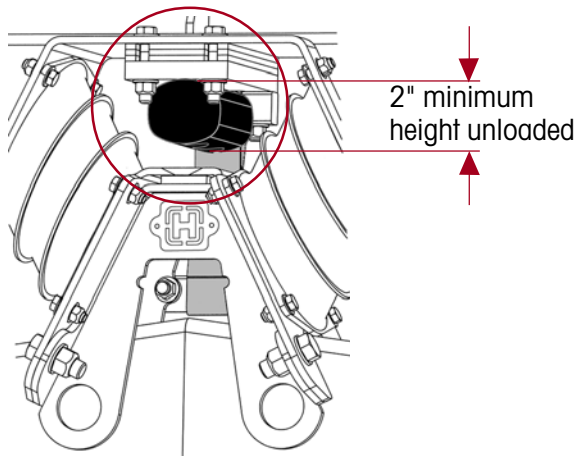
DISCONTINUED Auxiliary Spring Assembly 58189-000

Effective August 1998, Hendrickson replaced the auxiliary spring assembly in production for the HN-402/462. The new auxiliary spring maintains a higher level of performance and durability in severe applications and is completely interchangeable with the discontinued auxiliary spring assembly. The discontinued auxiliary spring assemblies are obsolete and no longer available, see list below for the new auxiliary spring assembly kits.

Periodic inspection of the auxiliary spring is required. Replacement is needed if the unloaded height of the auxiliary spring is less than the minimum as shown in the views above. It is recommended that both sides of the tandem are replaced with the new auxiliary spring to operate properly. For HN-402/462 auxiliary spring replacement instructions, see Technical Publication 17730-227.

Service Kit to replace discontinued auxiliary spring:	(part no. 58189-000)	57974-011
Service Kit to replace new auxiliary spring:	(part no. 58947-000)	57974-012
