# **H** TECHNICAL BULLETIN

## AIRTEK RIDE HEIGHT ADJUSTMENT PROCEDURE

SUBJECT: AIRTEK™ for Freightliner Vehicles

LIT NO: SEU-0211

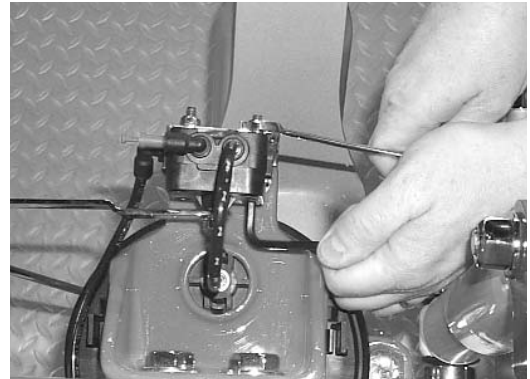
Figure 1

Hendrickson has learned of a potential service issue regarding the height control valve on vehicles equipped with the AIRTEK suspension. After performing a ride height adjustment procedure, the bottom socket head cap screws may loosen up if the 1/4" height control valve mounting locknuts are not properly re-tightened. Loose cap screws may cause an air leak between the two halves of the height control valve body. Such an air leak may affect suspension performance and proper operation of air system components in the suspension.

1. Prior to adjusting the height control valve, clean the threads of the 1/4" fasteners of any debris and corrosion.
2. After the adjustment is made, install a 3/16" allen wrench in the bottom socket head cap screws to prevent the screws from turning while re-tightening the 1/4" locknuts. See Figure 1.
3. Re-tighten the locknuts to 7-10 foot pounds torque. See Figure 2.
