TECHNICAL BULLETIN

TIREMAAX® TIRE INFLATION SYSTEM

SUBJECT: Alternative Wheel Removal and Installation Procedure

LIT NO: B116

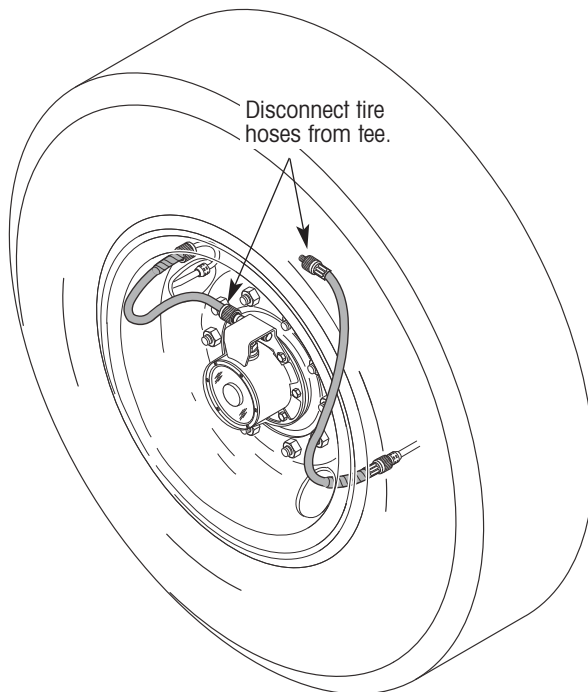
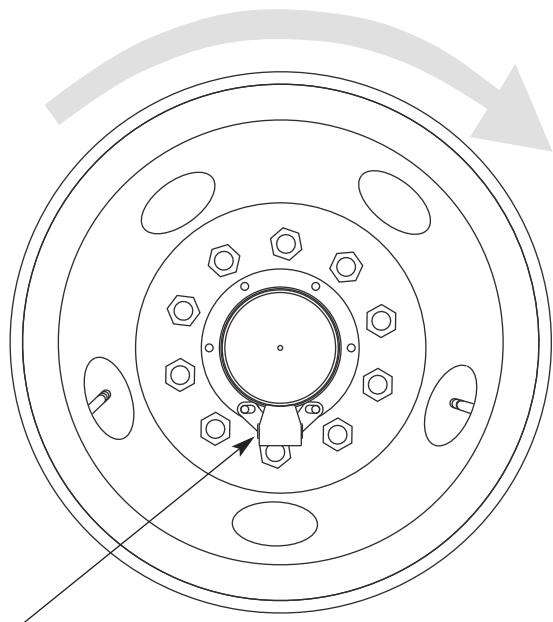
As an alternative, you can remove the wheel assembly with the tee fitting still installed on the hubcap **as long as the wheel assembly is rotated so that the tee fitting is in the six o'clock position**. With the tee fitting in the six o'clock position, it is more protected from potential damage when the wheel assembly drops down onto the hub after clearing the wheel studs. Note that if a wheel dolly is being used, the wheel must be lowered to clear the tee fitting.
