H TECHNICAL PROCEDURE

HENDRICKSON TRAILER AXLES

SUBJECT: S-cam and Brake Chamber Bracket Replacement Procedure

LIT NO: L1009

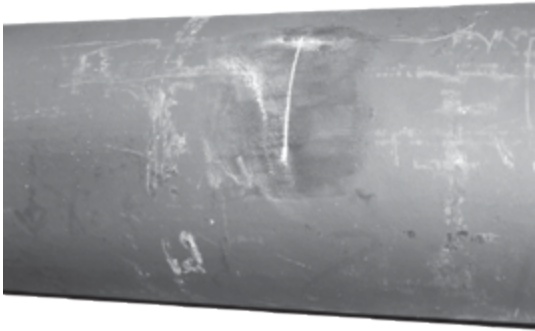
Figure 1: Previous bracket weld ground flush to axle tube surface

2. **Remove** damaged S-cam bracket:
 - A. **Grind** away any remaining weld or S-cam bracket material from the axle tube (Figure 1).
 - B. **If** bracket had been rewelded:
 - i. Use a cutting torch (oxy-fuel, plasma) to **remove** the majority of the bracket. Cut approximately 1/4 inch above the weld.
 - ii. **Grind** remaining material from axle tube.

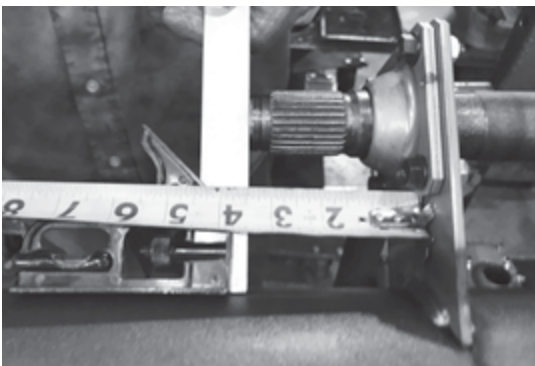
Figure 2: S-cam bracket assembly must be 3.5 inches (90 mm) from the end of the camshaft

3. **Position** replacement bracket on axle (Figure 2):
 - A. **Slide** a new S-cam bracket assembly onto the camshaft and **place** the bracket assembly on the axle tube.

- B. **Position** the S-cam bracket assembly on the axle tube so the camshaft is parallel to the axle tube and **aligned** with the other camshaft on the opposite end of the axle tube. Visual placement is acceptable, but the goal is to minimize misalignment.

Position the S-cam bracket assembly laterally on the axle tube (Figure 2) so the inside surface of the S-cam bracket assembly is 3 1/2 inches (90 mm) from the end of the camshaft.

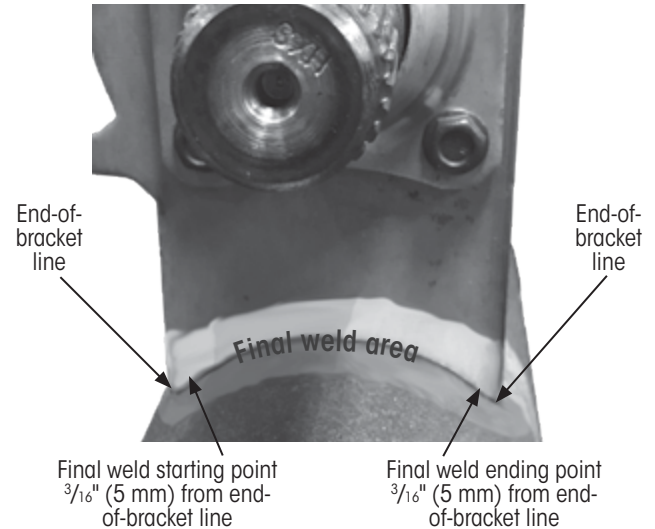
Figure 3: Weld placement layout

4. Using a felt-tip marker, **place** layout lines for the final weld on the axle tube (Figure 3).
5. **Ensure** both items to be welded are free from moisture, dirt, scale, paint and grease.

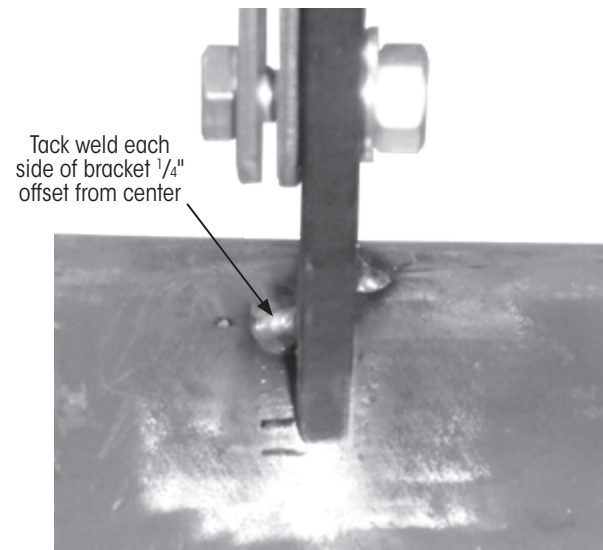
Figure 4: S-cam bracket tack weld placement

6. **Tack weld** each side of the S-cam bracket assembly (Figure 4) in place on the axle tube. The tack welds should be offset from each other about $\frac{1}{4}$ inch (6 mm) from the center of the S-cam bracket.
7. **Remove** the camshaft and S-cam support bushing assembly from the S-cam bracket assembly so that a good fillet weld, attaching the S-cam bracket to the axle tube, can be completed.

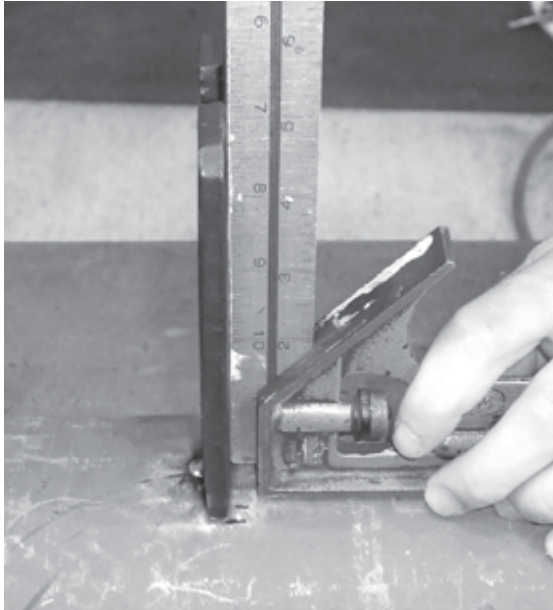
Figure 5: S-cam bracket must be perpendicular to axle tube

8. Using a square, **check** the perpendicularity of the S-cam bracket to the axle tube (Figure 5). Make any adjustments prior to final weld.
9. **Thoroughly clean** the slag from the tack welds before applying the final welds.

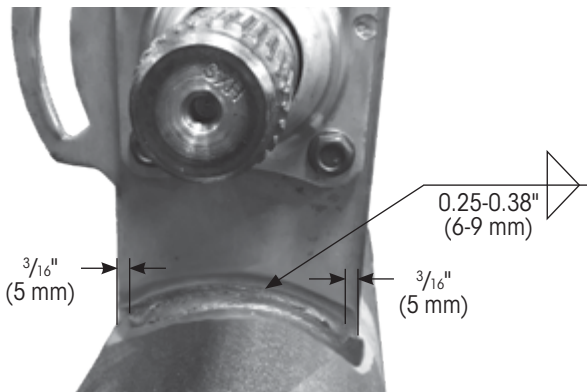
Figure 6: Final S-cam bracket weld

10. **Apply** final fillet weld using these specifications:
 - Weld size should be $\frac{1}{4}$ to $\frac{3}{8}$ inches (6 to 10 mm) and should stop $\frac{3}{16}$ inches (5 mm) from both ends (Figure 3 and Figure 6).
 - There should be two separate welds, one on each side of the S-cam bracket, that do not extend around the ends of the bracket. Wrapping the weld around the ends of the S-cam bracket can lead to undercutting.
11. **Thoroughly clean** the slag from welds and **apply** surface coat.
12. **Reinstall** the camshaft and S-cam support bushing assembly.
13. Fully **lubricate** both spider and cam bushings.

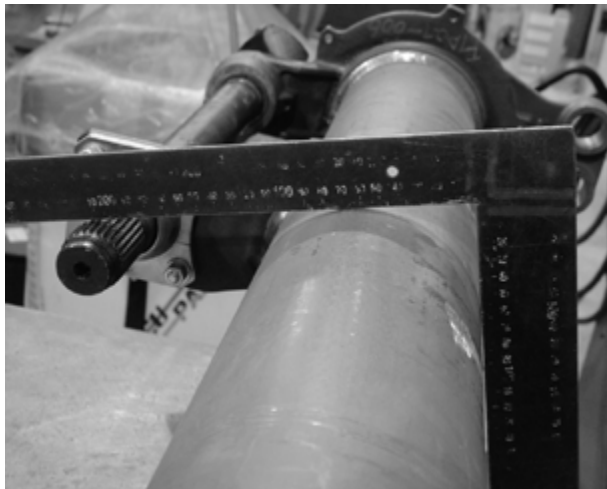
Figure 7: Framing square helps position brake chamber bracket

3. **Place** a framing square on the axle contacting the camshaft splines as shown in Figure 7 and Figure 8.

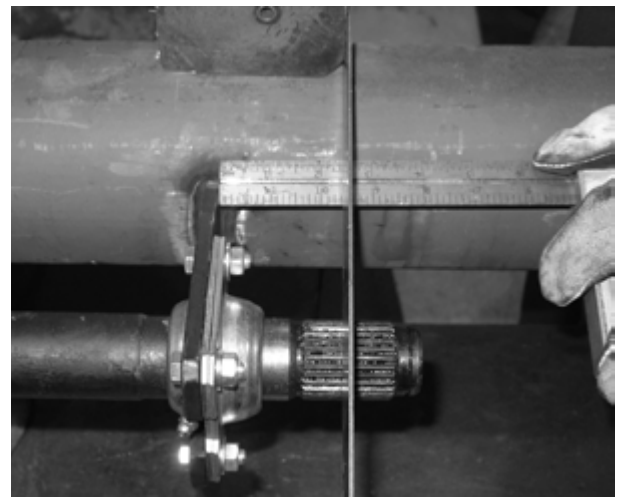
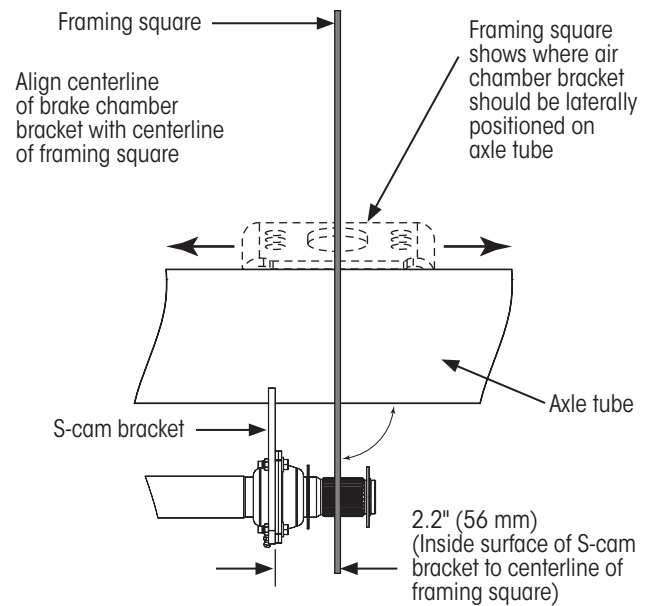
Figure 8: Using a framing square to determine brake chamber bracket placement

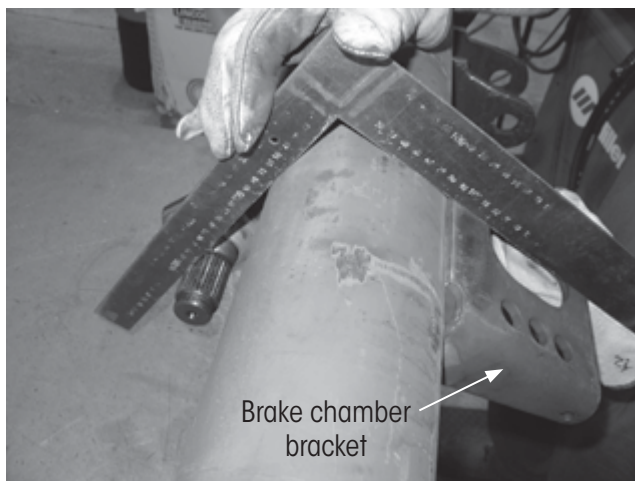
Figure 9: Tangentially positioning brake chamber bracket

4. **Place** a new brake chamber bracket on the axle tube and orient so that it contacts framing square as shown in Figure 9.
5. **Ensure** the items to be welded are free from moisture, dirt, scale, paint and grease.

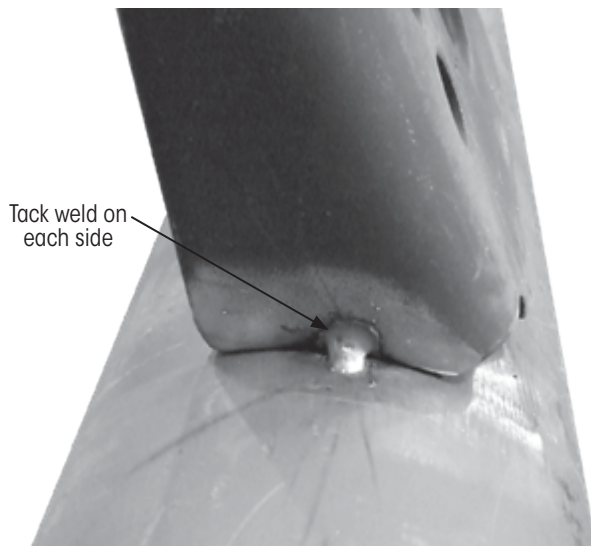
Figure 10: Tack weld brake chamber bracket to axle tube

6. **Tack weld** the brake chamber bracket in place using a $\frac{1}{4}$ inch (6 mm) tack weld on both sides of the brake chamber bracket (Figure 10). Tacks should be near the center of the bracket.

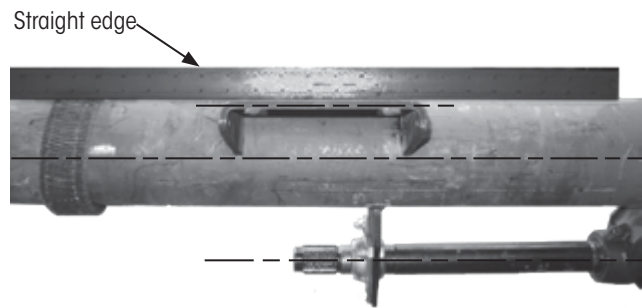
Figure 11: Brake chamber brackets must be parallel to axle tube

7. **Position** the brake chamber bracket so its mounting surface is parallel to the other brake chamber bracket on the opposite end of the axle tube (Figure 11). If possible, lay a straight edge across the brake chamber bracket to **check** parallelism to the other bracket or to the axle tube. **Make any adjustments prior to final weld.**
8. **Thoroughly clean** the slag from the tack welds before applying the final welds.

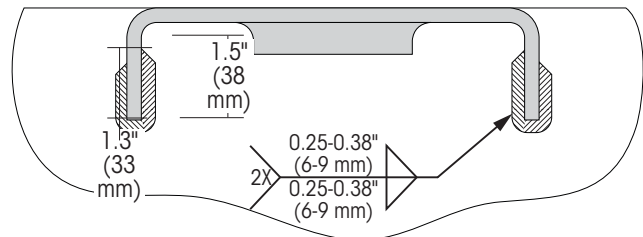
Figure 12: Brake chamber bracket weld specifications

9. **Apply** $\frac{1}{4}$ to $\frac{3}{8}$ inch (6 to 10 mm) fillet weld to each side of the bracket (Figure 12):

NOTE: The resulting weld should wrap around the end of the bracket. Use extra caution to avoid undercut when wrapping the weld around the end of the bracket.

- A. The **first weld** should be made on the inside of the bracket and end with just a slight wrap around the edge of the bracket.
- B. The **second weld** should be made on the outside of the bracket and end so that it overlaps the end of the first weld.

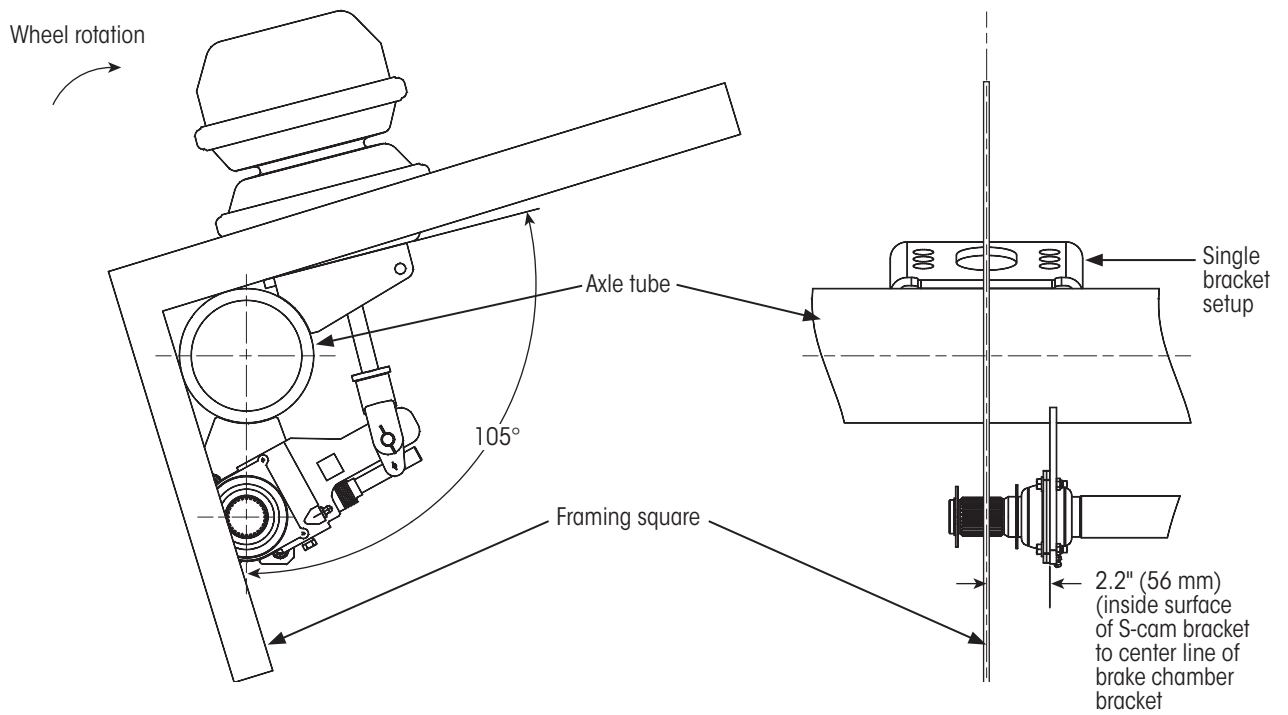
This procedure should create the **optimum 105 degree setup angle** as shown in Figure 13.

Figure 13: Brake chamber bracket positioning details
