# **H**TECHNICAL **PROCEDURE**

## **PIVOT BUSHINGS**

**SUBJECT:** Bushing Tube Spacer Inspection / Replacement Procedure

**LIT NO:** L750

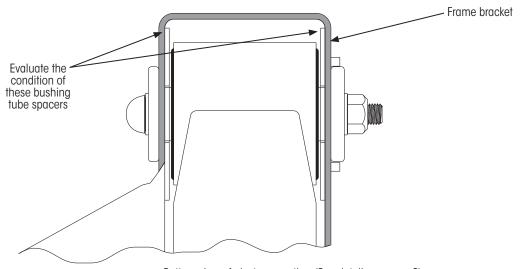
Figure 1: Bushing tube spacer location

Bottom view of pivot connection (See details on page 8)

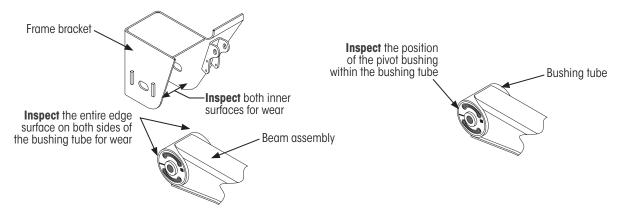
Figure 4: Pivot connection component inspection

If a missing, cut or otherwise worn through bushing tube spacer is discovered, the suspension pivot connection must be disassembled and the beam assembly lowered to check for potential beam and/or frame bracket wear (<u>Figure 4</u>). Refer to Hendrickson literature number <u>L427 Bushing Replacement Procedure</u> for complete pivot connection disassembly instructions.

With the beam assembly lowered (<u>Figure 4</u>), inspect inner surfaces of the frame bracket and edges of the bushing tube for wear. Also inspect the position of the pivot bushing within the bushing tube. The condition of these three areas will dictate the repair requirements or the necessity to replace any parts as instructed in <u>Table 2 on page 6</u>.

With the beam assembly lowered (<u>Figure 4</u>), inspect the inner surfaces of the frame bracket. Some wear (polished metal) on the inner surface of the frame bracket is considered normal due to the pivoting motion inherent with this connection. Gouges or grooves worn into the frame bracket are abnormal. If any gouges, grooves or missing metal is found, the frame bracket must be replaced. For complete frame bracket replacement instructions, refer to applicable Hendrickson literature listed at the top of page 2.

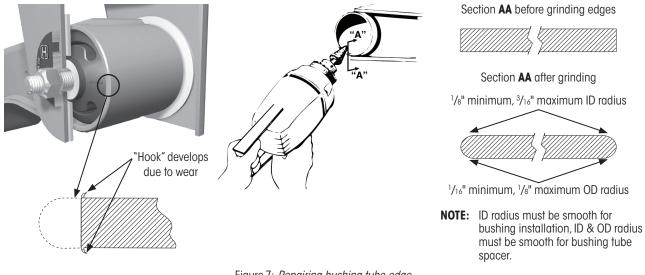
Figure 7: Repairing bushing tube edge

When the bushing tube wears, a slight "hook" or "tooth" of metal may develop on both inside and outside diameters of the tube (Figure 7). As the vehicle turns, the unique design of the pivot bushing allows it to elongate sightly to absorb the forces associated with road surface, load, etc. When the turn is complete and those particular forces are no longer present, the pivot bushing returns to its original position. If the "hook" or "tooth" on the bushing tube is not removed, it can "bite" into the rubber pivot bushing when elongated and hold or prevent it from returning to its original position, which is unacceptable. As this is repeated, the pivot bushing can eventually be pulled out of the bushing tube. The rubber pivot bushing may also become damaged by these irregular edges.

Before attempting to install a new bushing, the worn bushing tube edge must be dressed. Use a grinder to re-establish a radius on the edge of the bushing tube as shown in <u>Figure 7</u> and defined in <u>Table 2</u>.
