TECHNICAL PROCEDURE

ULTIMAAX® Rear Suspension for Tata Motors Limited

SUBJECT: Service Instructions

LIT NO: 17730-293

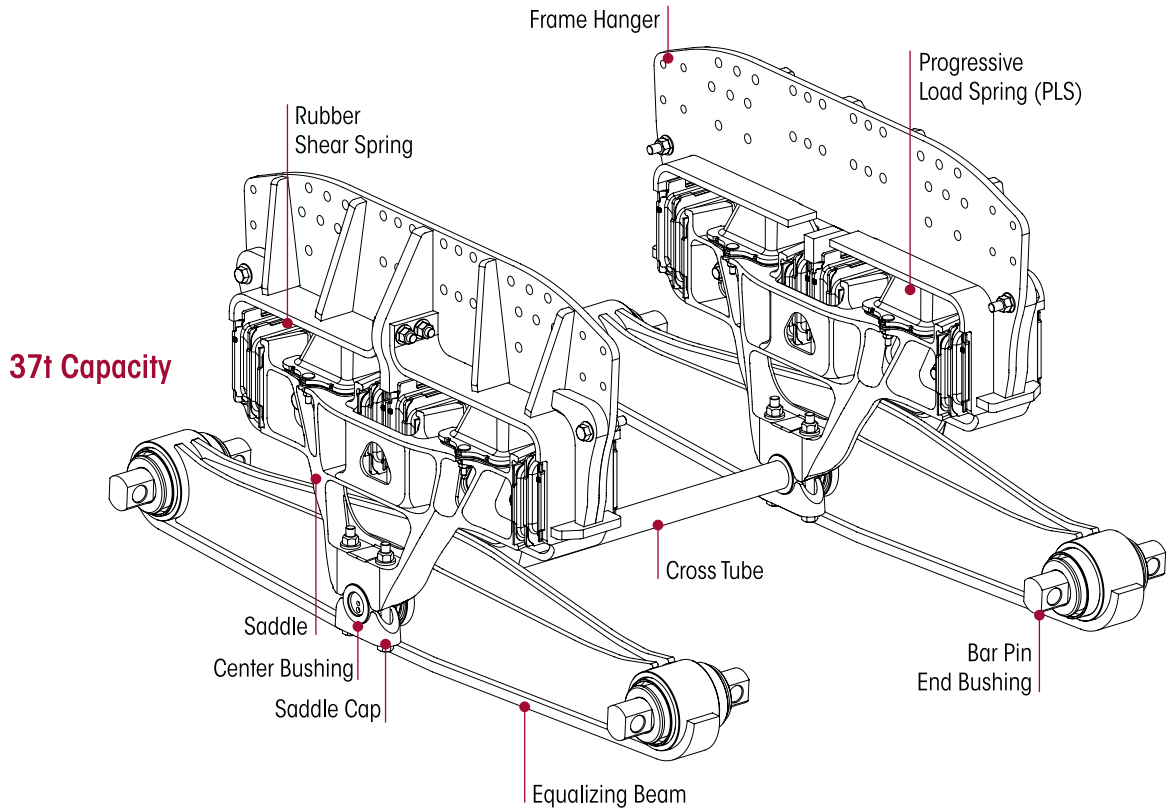
FIGURE 2-1

- **Saddle** — Triangular geometry provides structure and durability. Lightweight design helps to increase payload, while offering a considerable weight savings versus competitive suspensions.

- **Frame hangers** — Optimized design to balance durability and weight savings. Fabricated to offer flexibility with multiple truck configurations.
- **Rubber shear springs** — Primary springs in unloaded condition, providing superb ride quality. React to longitudinal loads during braking and accelerating for minimal displacement.

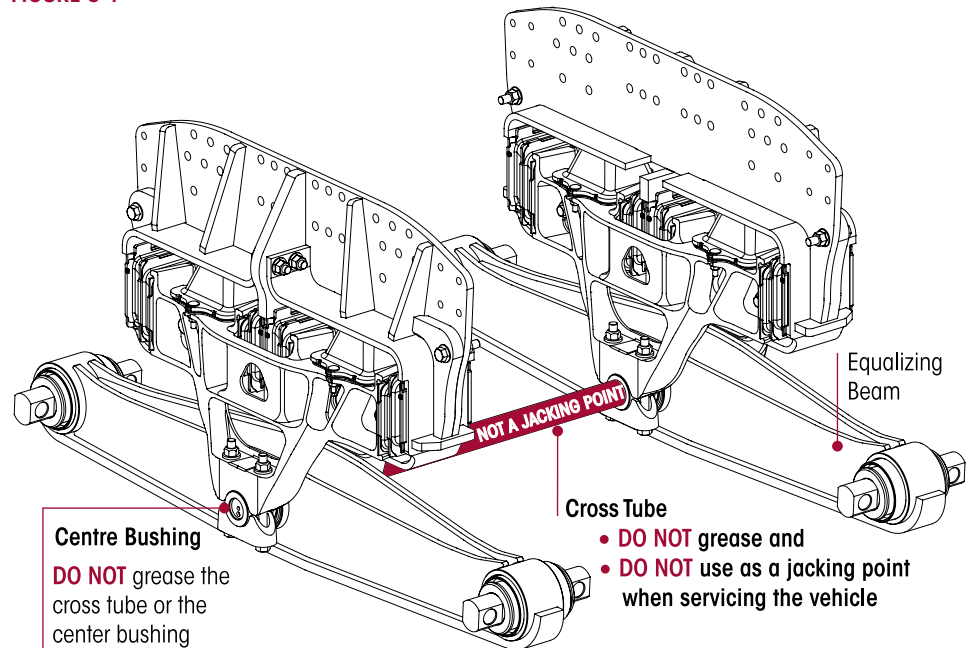
FIGURE 3-1

IMPROPER JACKING METHOD

IMPROPER JACKING METHODS CAN CAUSE STRUCTURAL DAMAGE WHICH CAN CAUSE ADVERSE VEHICLE HANDLING, PROPERTY DAMAGE OR SEVERE PERSONAL INJURY.

- DO NOT USE THE SUSPENSION CROSS TUBE, BAR PIN BUSHING OR AXLE BRACKET AS A JACKING POINT, SEE FIGURES 3-1 AND 3-3, CONSULT SERVICE MANUAL FOR PROPER JACKING INSTRUCTIONS.
- ACCEPTABLE LIFTING POINTS FOR A VEHICLE INCLUDE BUT ARE NOT LIMITED TO: THE AXLE, EQUALIZING BEAM (SEE FIGURE 3-2), AND THE VEHICLE FRAME RAIL. REFER TO THE VEHICLE SERVICE MANUAL FOR PROPER JACKING INSTRUCTIONS.
- RECOMMENDED: A 30 TON 2 STAGE BOTTLE JACK IS SUFFICIENT TO FIT UNDER THE EQUALIZING BEAM, WITH A CLOSED HEIGHT OF 185 MM AND OPEN HEIGHT OF 290 MM, SEE FIGURE 3-2.

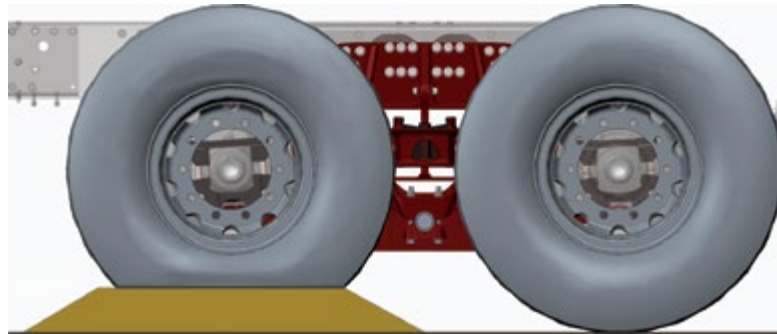
FIGURE 3-4

- IF ADDITIONAL CLEARANCE IS NECESSARY, SUCH AS IF TWO TIRES ARE DEFLATED ON THE SAME SIDE OF THE VEHICLE, CAREFULLY DRIVE THE WHEELS OVER A RIGID BLOCK OR PLY OR A SECURE SPACER TO RAISE THE VEHICLE TO PROVIDE SUFFICIENT LIFTING CLEARANCE UNDER THE AXLE OR EQUALIZING BEAM, SEE FIGURE 3-4.

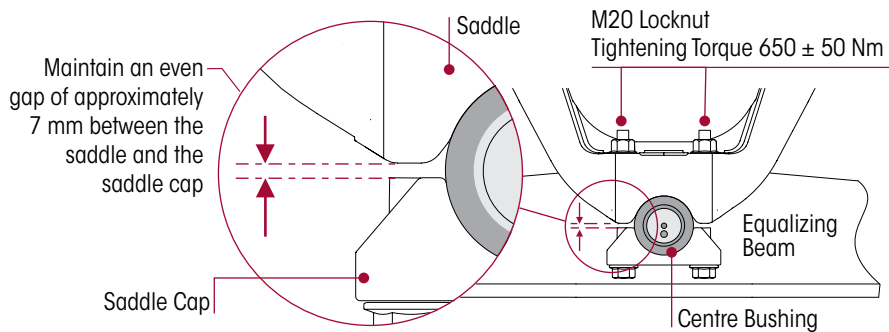
FIGURE 3-5

A SADDLE IS ATTACHED TO THE CENTRE BUSHING OF EACH EQUALIZING BEAM WITH TWO (2) SADDLE CAPS. EACH SADDLE CAP USES TWO (2) BOLTS TO CLAMP THE CENTRE BUSHING INNER METAL TO THE SADDLE. EACH SADDLE CAP MUST BE INSTALLED SO THAT THERE IS AN EVEN GAP OF APPROXIMATELY 7 MM BETWEEN THE SADDLE CAPS AND THE BASE OF THE SADDLE LEGS AS SHOWN IN FIGURE 3-5. IF EACH SADDLE CAP IS NOT INSTALLED EVENLY THE SADDLE LEGS COULD BECOME DEFORMED, RESULTING IN BENT BOLTS OR DAMAGED SADDLES.

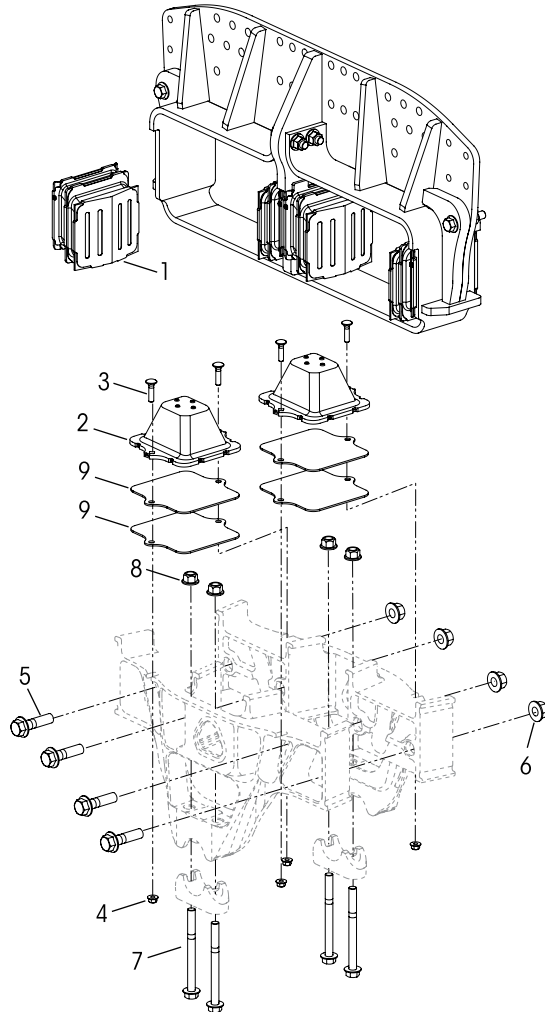
Shear and Progressive Load Spring
One Side

KEY NO.	PART NO.	DESCRIPTION	QTY.
1		*Shear Spring	4
2		*Progressive Load Spring	2
3		*M10 x 1.5-6g x 35 mm Round Head Square Neck Bolt	4
4		*M10 x 1.5 Flange Locknut	4
5		*M20 x 1.5 x 75 mm Flange Bolt	4
6		*M20 x 1.5 Flange Locknut	4
7		*M20 x 1.5 x 185 mm Flange Bolt	4
8		*M20 x 1.5 Flange Locknut	4
9		*Spacer	4
10		P-80 / Pril Lubricant (soap water)	As Req.

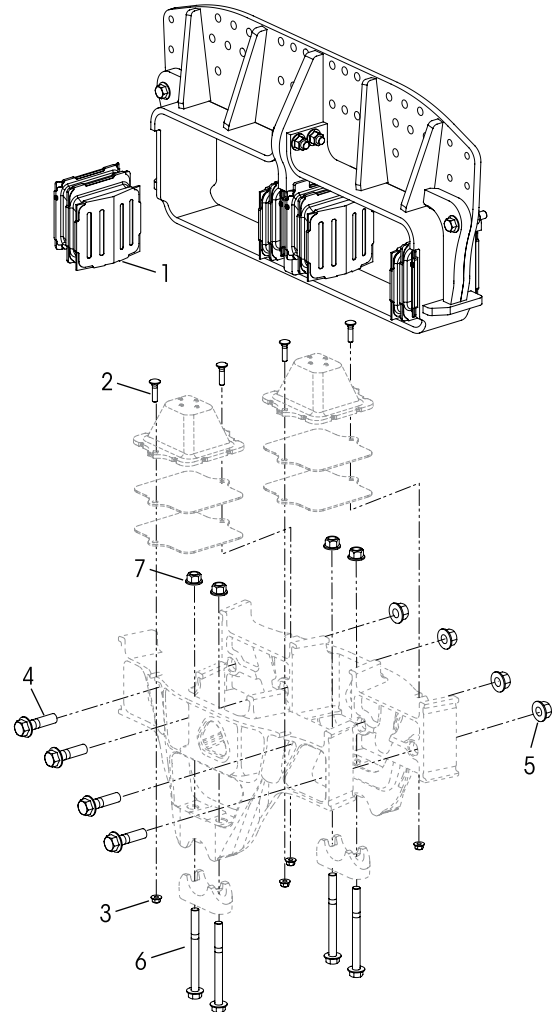
Shear Spring
One Side

KEY NO.	PART NO.	DESCRIPTION	QTY.
1		*Shear Spring	4
2		*M10 x 1.5-6g x 35 mm Round Head Square Neck Bolt	4
3		*M10 x 1.5 Flange Locknut	4
4		*M20 x 1.5 x 75 mm Flange Bolt	4
5		*M20 x 1.5 Flange Locknut	4
6		*M20 x 1.5 x 185 mm Flange Bolt	4
7		*M20 x 1.5 Flange Locknut	4
8		P-80 / Pril Lubricant (soap water)	As Req.

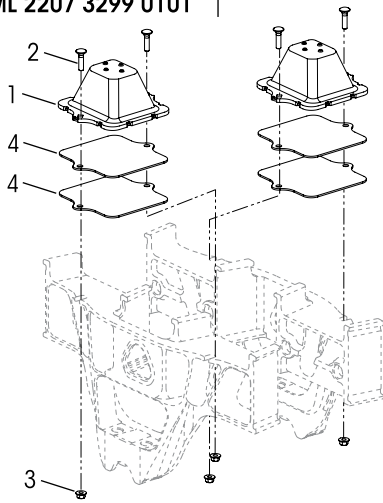
Progressive Load Spring
 One Side

KEY NO.	PART NO.	DESCRIPTION	QTY.
1		*Progressive Load Spring	2
2		*M10 x 1.5-6g x 35 mm Round Head Square Neck Bolt	4
3		*M10 x 1.5 Flange Locknut	4
4		*Spacer	4

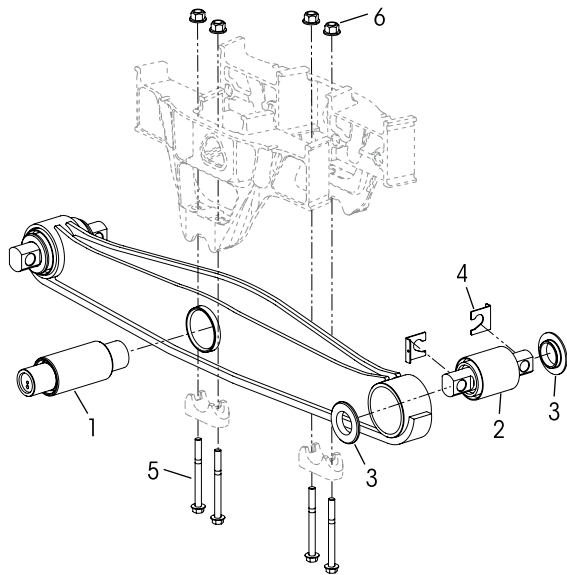
Equalizing Beam Bushings
 One Beam

KEY NO.	PART NO.	DESCRIPTION	QTY.
1		*Centre Bushing	1
2		*Bar Pin End Bushing	2
3		*Confinement Washer	4
4		*Axle Bracket Alignment Shims - 3 mm	4
5		*M20 x 1.5 x 185 mm Flange Bolt	4
6		*M20 x 1.5 Flange Locknut	4

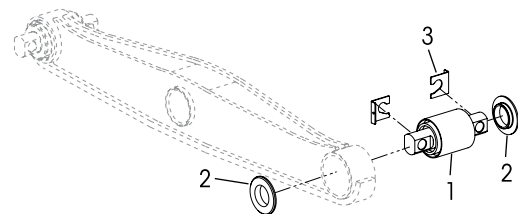
Bar Pin End Bushing
 One Wheel End

KEY NO.	PART NO.	DESCRIPTION	QTY.
1		*Bar Pin End Bushing	1
2		*Confinement Washer	2
3		*Axle Bracket Alignment Shims - 3 mm	2

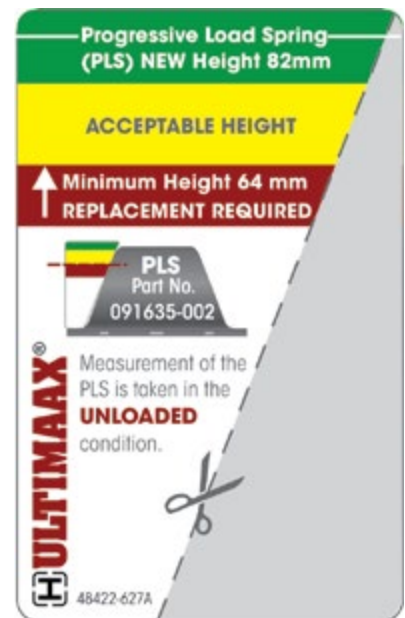
FIGURE 6-1

SERVICE HINT Use ULTIMAAX Gauge Card Literature Nos. 48422-627, Figure 6-1, to measure the progressive load spring (PLS) height.

- The height is below **64 mm** (Red Zone shown in gauge card, see Figure 6-1)
- A bent or cracked mounting base as shown in Figure 6-2
- Any cuts or splits in the rubber are over **50 mm in length** and an average **depth of 13 mm**, a certain amount of gradual breakup of the rubber surface is normal. The most probable areas for potential cuts, splits, or wear are shown in Figure 6-3 as “/////”.

The height of a new progressive load spring is **82 mm**, see Figure 6-3. The progressive load spring requires replacement as outlined in the Component Replacement Section in this publication if:

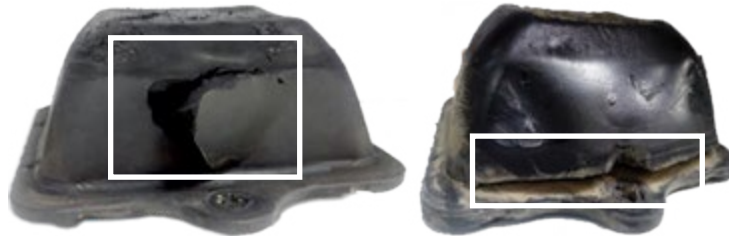
- The **bonding separation depth** of the rubber from the mounting base (see Figure 6-3) is more than 13 mm
- Creases formed by folding of the rubber surface under load are acceptable. These appear as stripes on the surface, polished by wear or covered with tacky (sticky) rubber, see Figure 6-4.

FIGURE 6-2
PROGRESSIVE LOAD SPRING - Failed Appearance

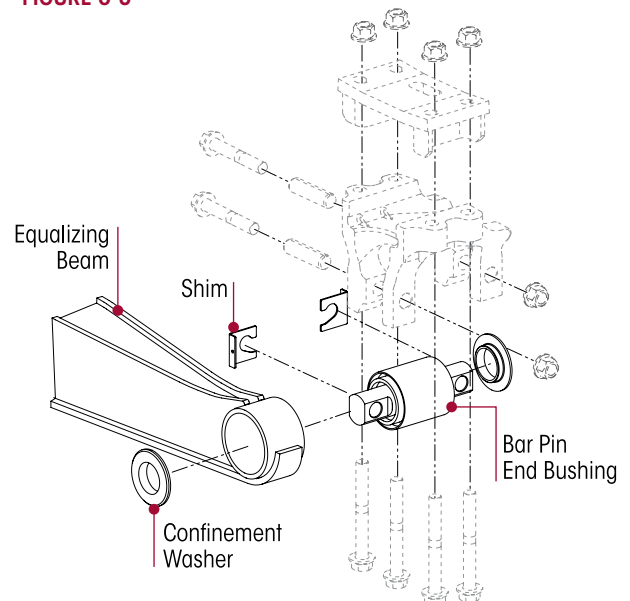
FIGURE 6-5

The equalizing beam end bushing for the ULTIMAAX is a bar pin style rubber bushing, see Figure 6-5. An inspection of the beam end connection is necessary when a vehicle is in the shop for major repair work and at regular preventive maintenance intervals.

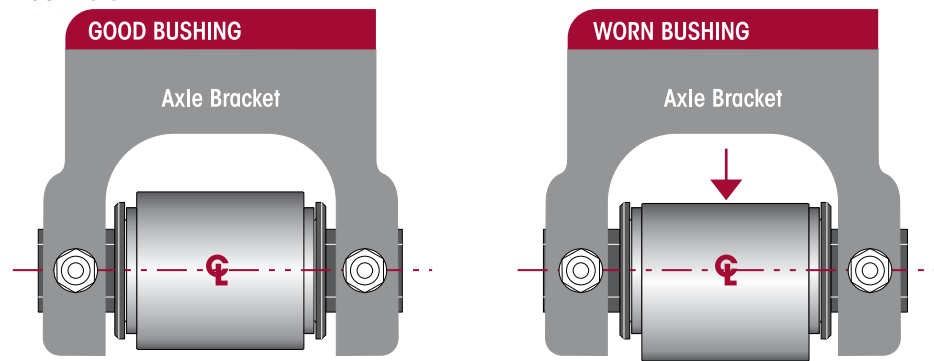
FIGURE 6-6

A **GOOD** bushing will result in the equalizing beam end hub appearing to be **centered** with the centerline of the bar pin in the axle bracket

A **WORN** bushing will result in the equalizing beam end hub appearing to be **offset/below** the centerline of the bar pin in the axle bracket

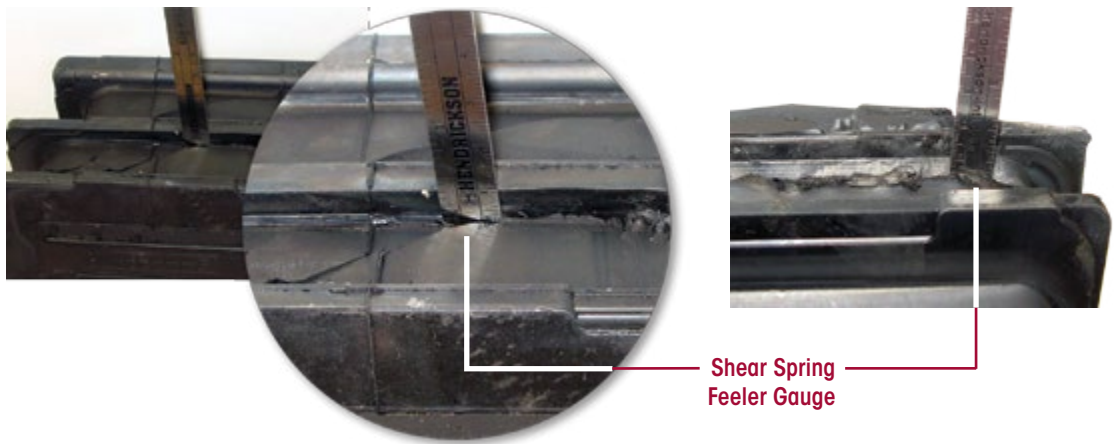
FIGURE 6-14

- Bonding separation of the rubber from any of the bonded rate plate surfaces to a maximum depth of approximately 50 mm is acceptable, see Figure 6-13. If the bonding separation depth is 50 mm or more, the shear springs require replacement.
- A certain amount of gradual breakup of the rubber surface is acceptable. Use a feeler gauge to measure cuts or splits in the rubber. If the measurement is over a depth of 50 mm, then the shear springs require replacement, see Figures 6-14 and 6-15.

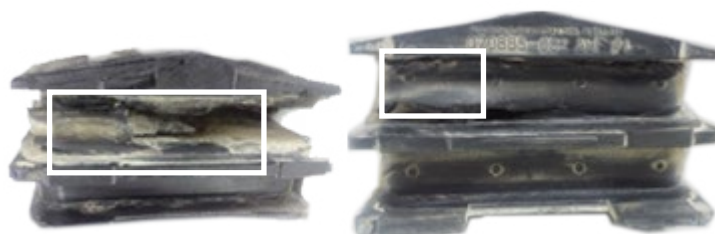
FIGURE 6-15

Shear Spring - Failed Appearance

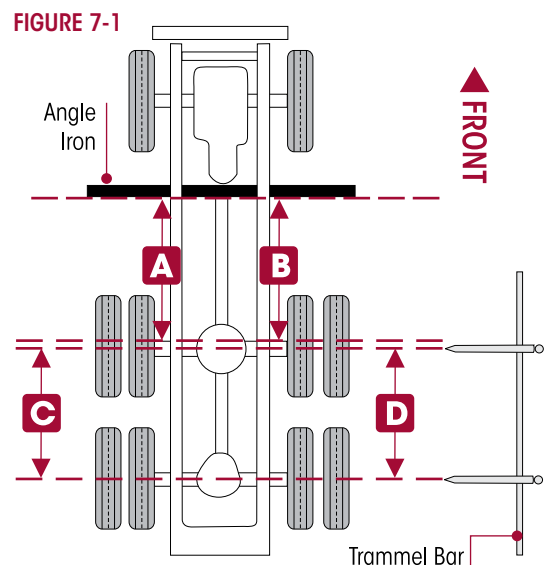
8. Using a measuring tape, measure from the straight edge to the forward face of the front drive axle arms on both sides of the vehicle as shown in Figure 7-1, **A** and **B**.
9. Calculate the difference between measurements **A** and **B**.
 - a. If the front drive axle is within vehicle manufacturer's specifications, proceed to check the rear drive axle (Step 11).
 - b. If alignment of the front drive axle **IS NOT** within the vehicle manufacturer's specifications, then the alignment of this axle **MUST** be corrected **BEFORE** measuring the rear drive axle alignment (Step 11).
 - c. Correct the alignment of this axle by following the bar pin alignment instructions.

2. To determine where to adjust shim thickness use measurement **A** and **B** for front drive axle or **C** and **D** for rear drive axle, see Figure 7-1.

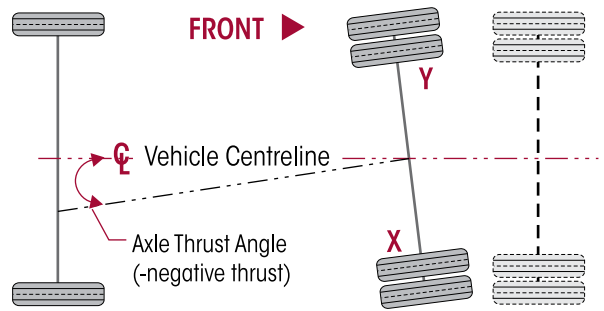
FIGURE 7-4

Axle adjustment will be on the side of the bar pin where shim thickness is increased. For example, to correct the axle thrust angle illustrated in Figure 7-4, shim thickness will need to be increased at the front of the bar pin (**Location X**) and/or the rear of the bar pin (**Location Y**), see Figure 7-6.

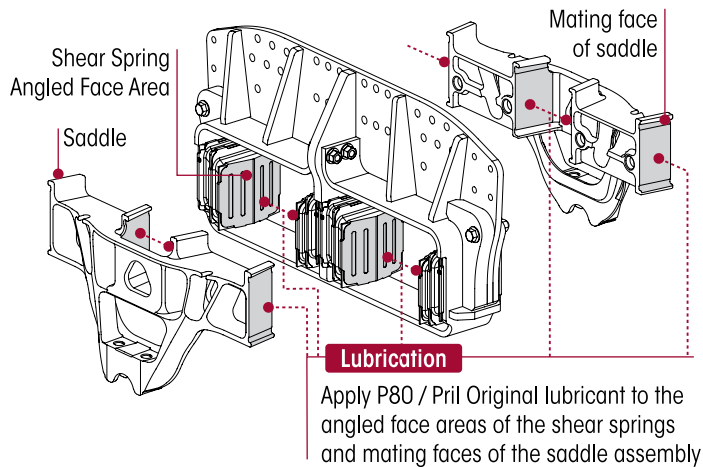
FIGURE 8-8

- Apply P-80 / Pril Original (soap water) or equivalent lubricant to the shear spring's angled face and to the mating face of the saddle halves, see Figure 8-7.
- Apply NLGI #2-EP (Extreme Pressure) chassis lubricant to the threaded rod of the Saddle Assembly Installation Tool (THSL Part No. TRU3000011, TML Part No. 5064 5890 3207), see Figure 8-8.

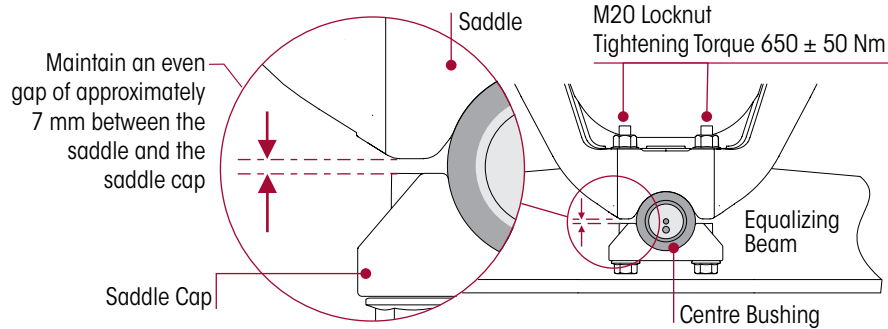
FIGURE 8-13

A SADDLE IS ATTACHED TO THE CENTRE BUSHING OF EACH EQUALIZING BEAM WITH TWO (2) SADDLE CAPS. EACH SADDLE CAP USES TWO (2) BOLTS TO CLAMP THE CENTRE BUSHING INNER METAL TO THE SADDLE. EACH SADDLE CAP MUST BE INSTALLED SO THAT THERE IS AN EVEN GAP OF APPROXIMATELY 7 MM BETWEEN THE SADDLE CAPS AND THE BASE OF THE SADDLE LEGS (FIGURE 8-13). IF EACH SADDLE CAP IS NOT INSTALLED EVENLY THE SADDLE LEGS (FIGURE 8-14) COULD BECOME DEFORMED, RESULTING IN BENT BOLTS OR DAMAGED SADDLES.

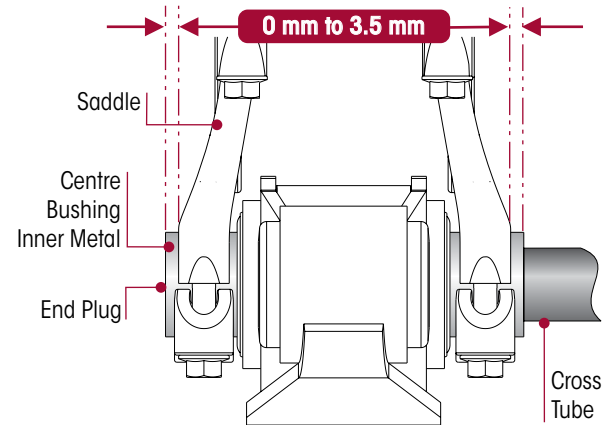
FIGURE 8-14

15. Center the saddle on the equalizing beam centre bushing, see Figure 8-14.

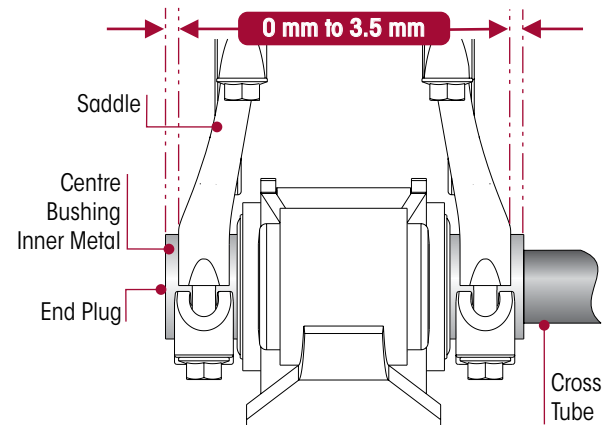
FIGURE 8-20

8. Center the saddle on the equalizing beam centre bushing, see Figure 8-20.

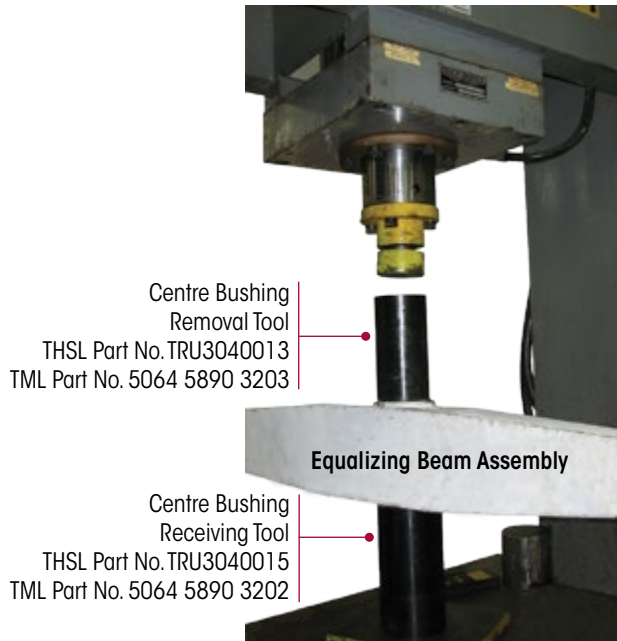
FIGURE 8-22

2. Place the equalizing beam assembly in a shop press with the centre hub firmly supported on the receiving tool or on the press, see Figure 8-22.
 - THSL Part No. TRU3040015
TML Part No. 5064 5890 3202
3. Install the centre bushing removal tool as shown in Figure 8-22, ensure it is centered on the centre bushing.
 - THSL Part No. TRU3040013
TML Part No. 5064 5890 3203
4. Push directly on centre bushing removal tool until the centre bushing is pressed out of the equalizing beam bore.
5. Inspect the beam bore.

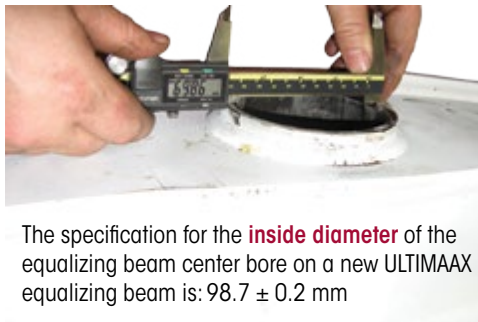
FIGURE 8-23

2. Measure the **inside diameter** of the equalizing beam centre bore. The specification for the inside diameter of the equalizing beam centre bore on a new ULTIMAAX equalizing beam is: 98.7 mm ± 0.2 mm
3. Calculate the mean of any two measurements 90° apart in the same plane, see Figure 8-23. If the mean is not within the specified range, replacement of the equalizing beam is required.

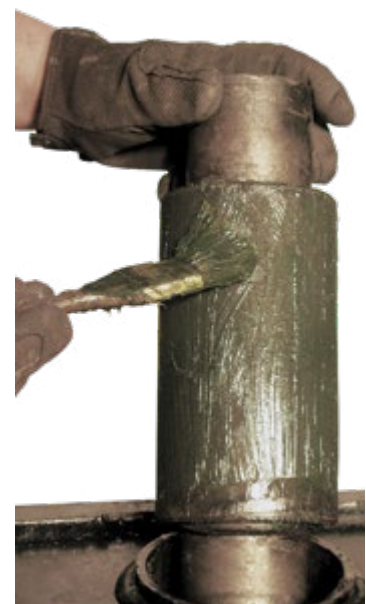
FIGURE 8-25

2. Place the equalizing beam in a shop press on the receiving tool or press. Support the beam squarely at the bore area to avoid distortion of the equalizing beam bore or bending of the equalizing beam.
3. Lubricate the equalizing beam bore and the equalizing beam centre bushing outer metal sleeve with an NLGI#2-EP (Extreme Pressure) grease, see Figure 8-25.

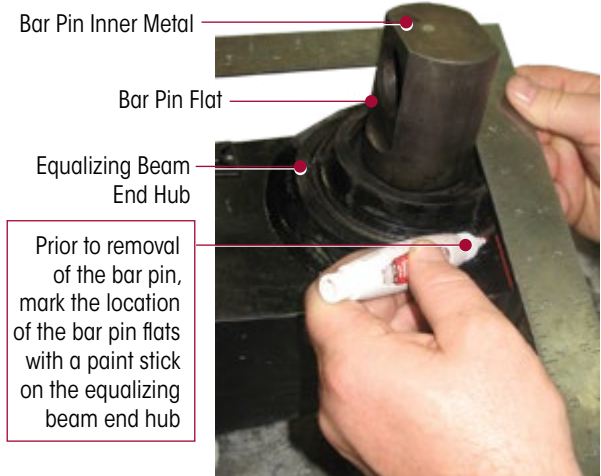
3. Prior to removal, mark the orientation of the bar pin flats on the equalizing beam with a paint stick, see Figure 8-31.
4. Support the beam end hub with it centered on the receiving tool. Be sure the equalizing beam is squarely supported on the press bed for safety.
5. Press on the end bushing inner metal, see Figure 8-31, of the end bushing until the inner metal is flush with the top of the equalizing beam end hub. This will move the bushing rubber away from the outer metal of the bushing so the removal tool can be installed.
6. Center the bushing removal tool directly on the bushing's outer metal and press the bushing out of the equalizing beam end hub

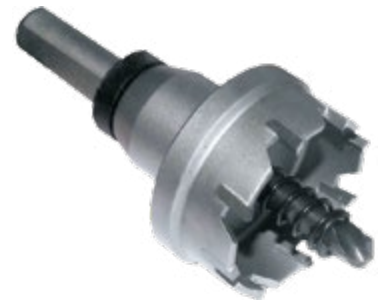
FIGURE 8-40 Hole Saw

- Cross Tube Service Kit No. 03AX010C09, see Parts Lists Section
- Cutting torch, welding equipment, hole saw, similar to the one shown in Figure 8-40.
