H TECHNICAL BULLETIN

VANTRAAX® HEIGHT CONTROL VALVE (HCV)

SUBJECT: Linkage Installation Tips

LIT NO: T89001

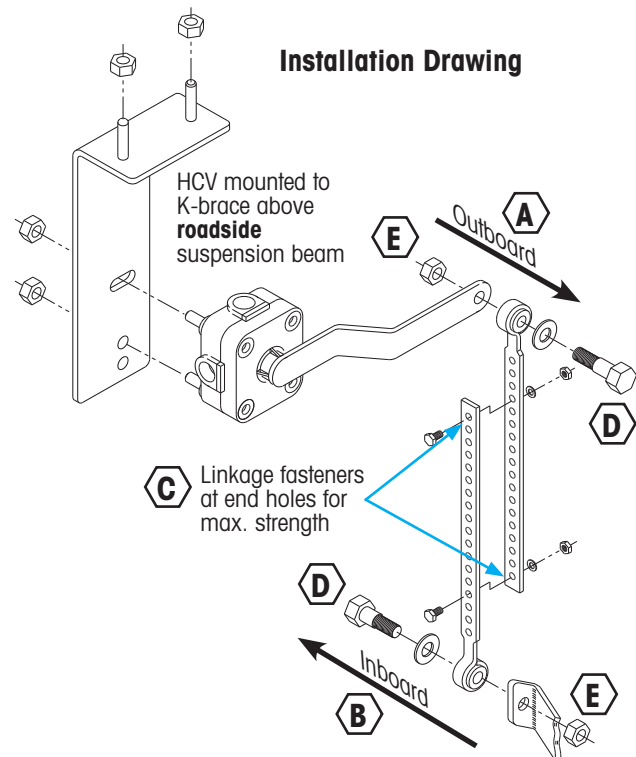
Installation Drawing

The HCV linkage connects the HCV arm to the suspension beam. For best performance, the **linkage should be installed vertically and must have freedom of movement** at top and bottom connections. The correct installation of the linkage is an important factor for extending the life of the components and for ensuring proper operation of the suspension:

TIP	NOTES
<ul style="list-style-type: none"> • Correctly locate the link 	<ul style="list-style-type: none"> A. Outboard side of HCV arm B. Inboard side of lower link bracket C. Insert linkage fasteners in last hole
<ul style="list-style-type: none"> • Install link bolts in the correct orientation 	<ul style="list-style-type: none"> D. Bolt head and flat washer on link side E. Nut against lower bracket or HCV arm
<ul style="list-style-type: none"> • DO NOT OVER TIGHTEN THE LINK BOLTS 	<ul style="list-style-type: none"> F. The link connection must be allowed to pivot freely G. The washer spins freely
<ul style="list-style-type: none"> • Use only Genuine Hendrickson HCV and linkage mounting hardware
