# TECHNICAL PROCEDURE INTRAAX®

**SUBJECT:** Shock Mount Assembly Procedure

**LIT NO:** L635

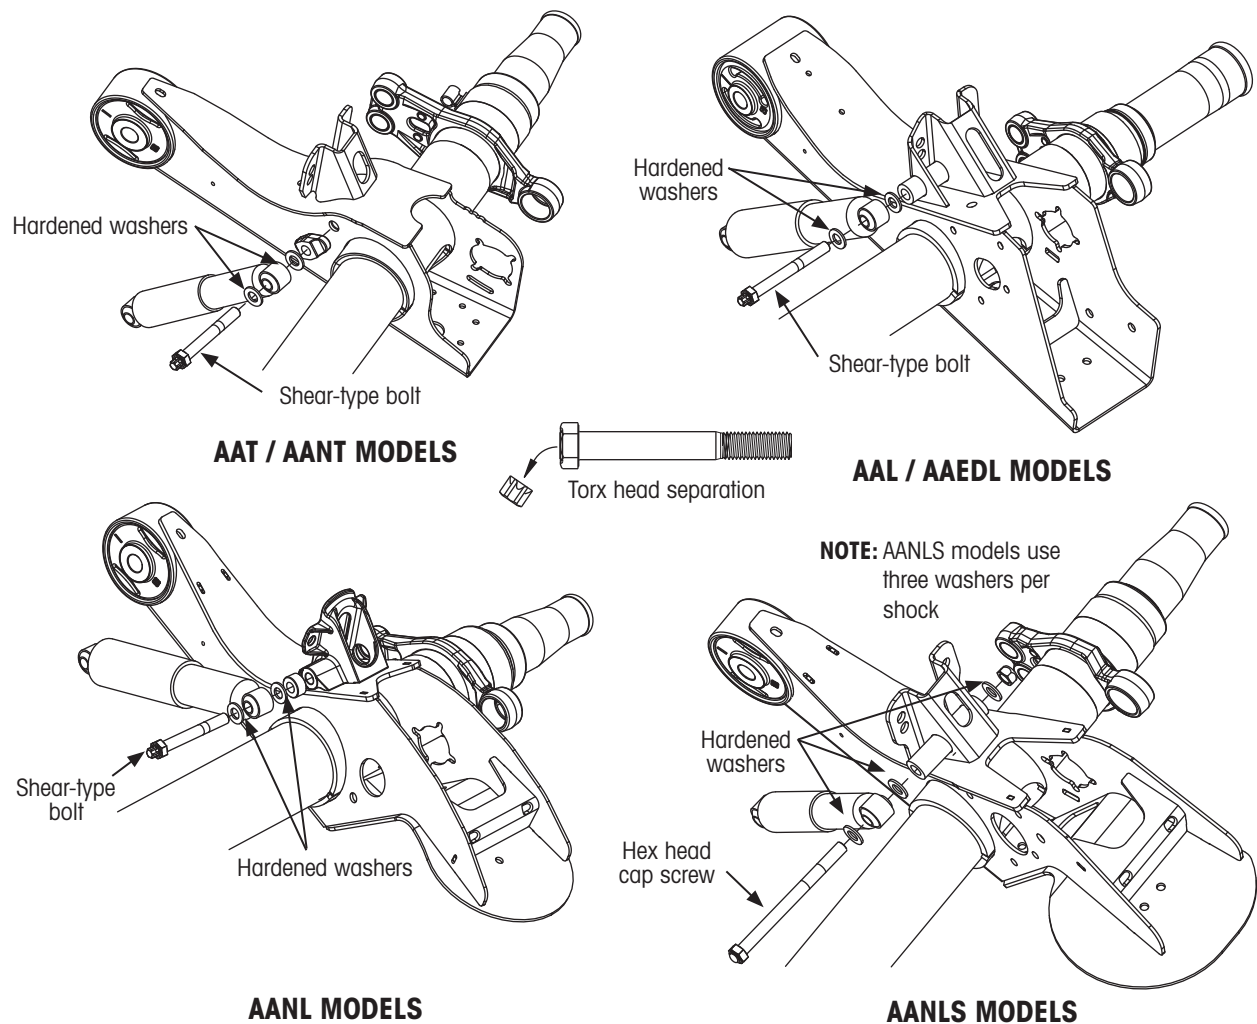
Figure 1: Lower shock mount assembly on suspensions without shock straps

Hendrickson uses a shear-type bolt in the lower shock absorber connection on many suspensions. To obtain the proper clamp load, install hardened washers on each side of the shock absorber bushing (Figure 1), or install the shock strap clevis (Figure 2), and tighten the shear-type bolt until the bolt's Torx head shears off. Use an E20 Torx socket to tighten and shear the bolt. Torx head separation occurs between  $222 \pm 12$  ft. lbs. ( $300 \pm 15$  N•m) of torque.

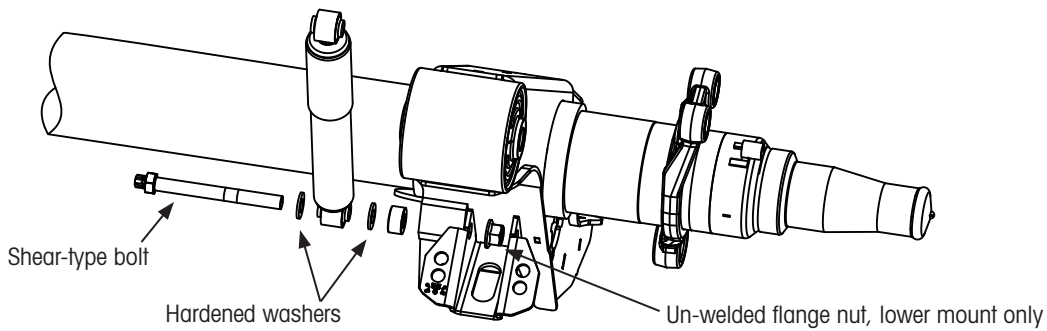
Figure 2: AAL lower shock mount with LDA axle

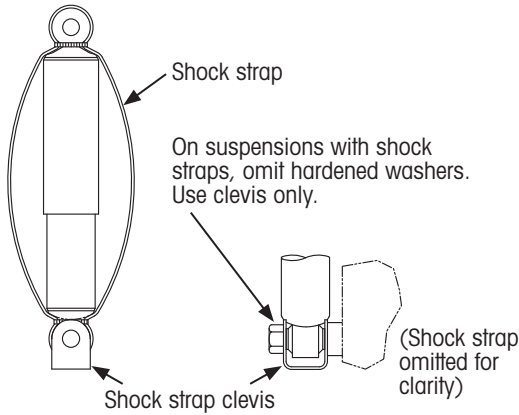
Figure 3: Lower shock mount assembly on suspensions with shock straps

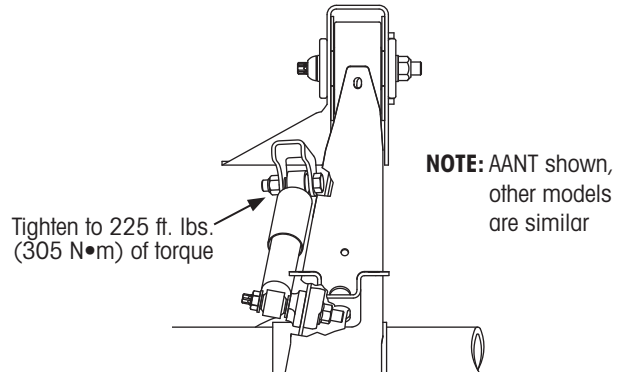
Figure 4: Upper shock mount assembly

The upper shock mount is tightened to 225 ft. lbs. (305 N•m) of torque (Figure 4).

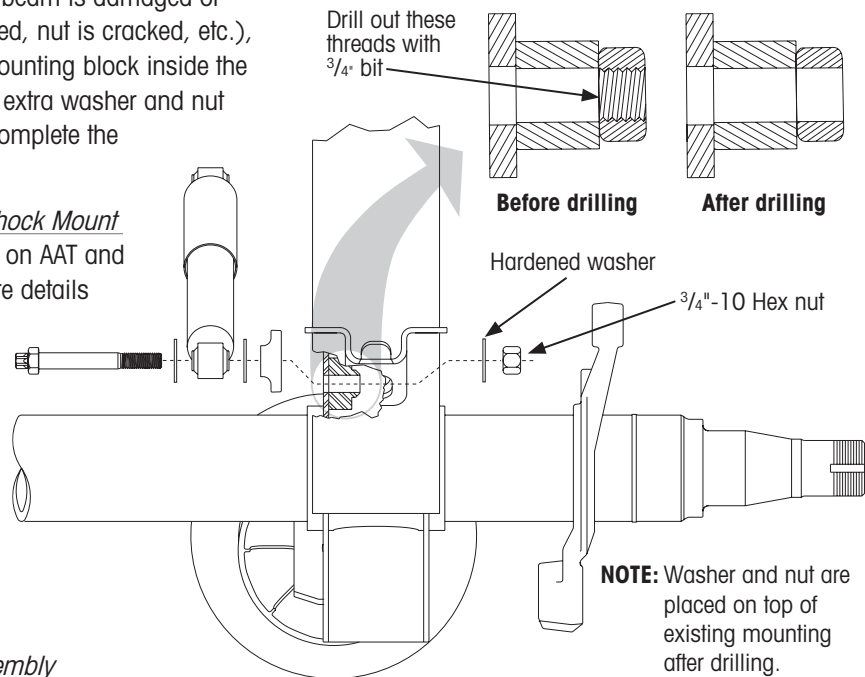
Figure 5: Damaged thread hardware assembly

If the nut on the inside of the suspension beam is damaged or cannot be reused (i.e., threads are stripped, nut is cracked, etc.), drill out the threads in the lower shock mounting block inside the suspension beam (Figure 5) and use the extra washer and nut provided in the shock bolt service kit to complete the lower shock mount.
