TECHNICAL PROCEDURE

OPTIMAAX® Lift Axle System Air Controller Module for Freightliner Vehicles

SUBJECT: Service Instructions

LIT NO: 17730-310

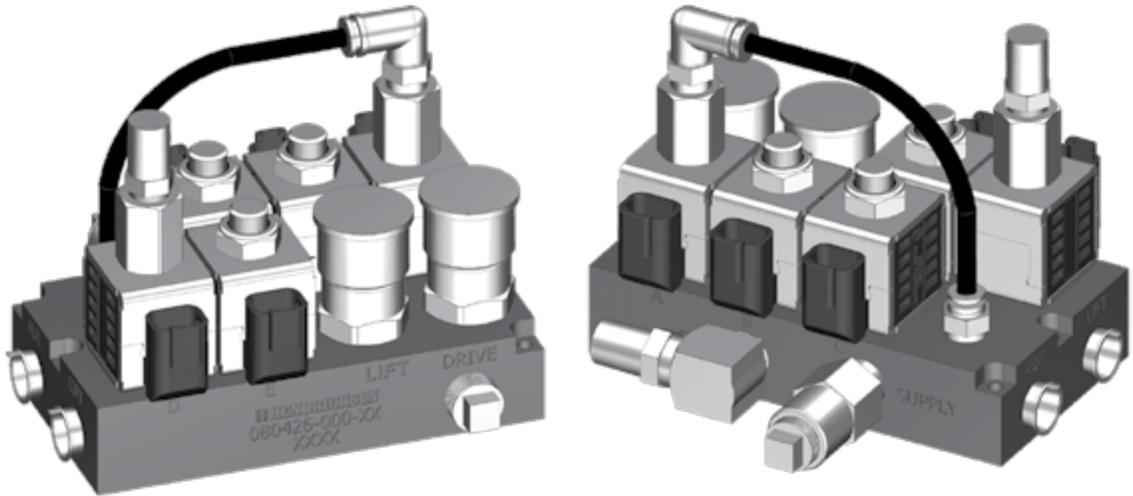
FIGURE 2-1 Air Controller Manifold

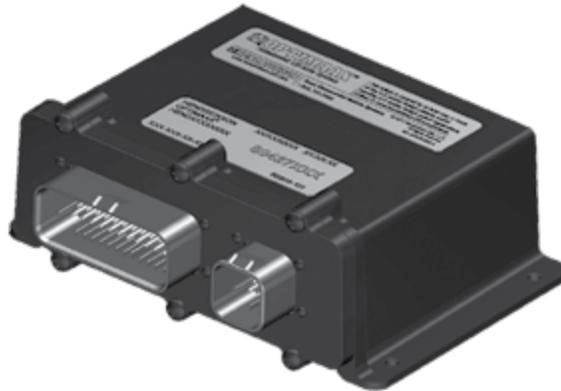
FIGURE 2-2 Electronic Control Unit (ECU)

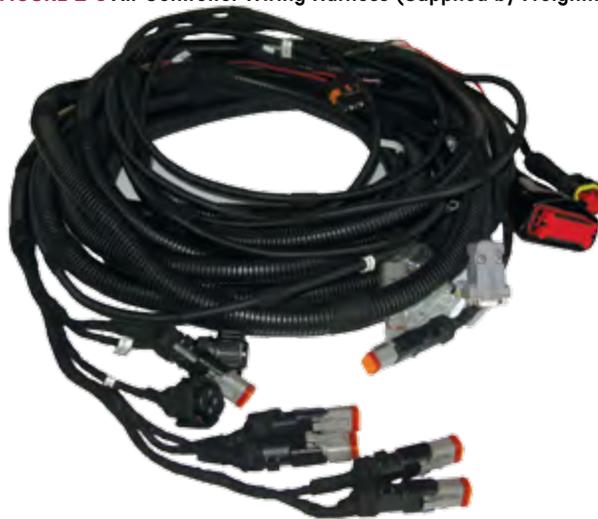
FIGURE 2-3 Air Controller Wiring Harness (Supplied by Freightliner)

Vehicles built **after** October 1, 2019
Freightliner Part No. A06-95748-777
HARN-AXLE-LIFT, OL, CHAS F, HDR
Freightliner Part No. A06-95749-000
HARN-AXLE-LIFT, OL, DASH, HDR, P4

Vehicles built **prior to** October 1, 2019
Freightliner Part No. A06-95715
HARN-AXLE-LIFT, CHAS, HDR
Freightliner Part No. A06-95709
HARN-AXLE-LIFT, DASH, HDR, P4

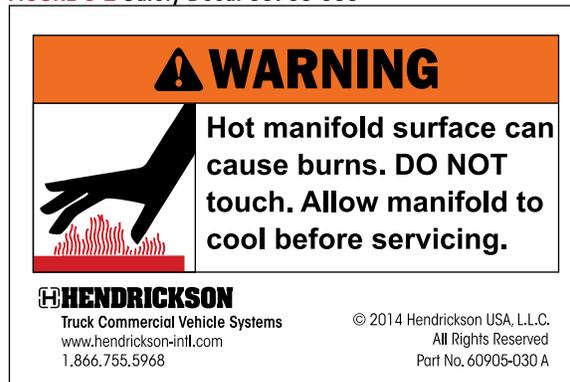
FIGURE 3-2 Safety Decal 60905-030

HOT AIR CONTROLLER MANIFOLD SURFACE CAN CAUSE BURNS. DO NOT TOUCH. ALLOW MANIFOLD TO COOL BEFORE SERVICING, SEE FIGURES 3-2 AND 3-3.

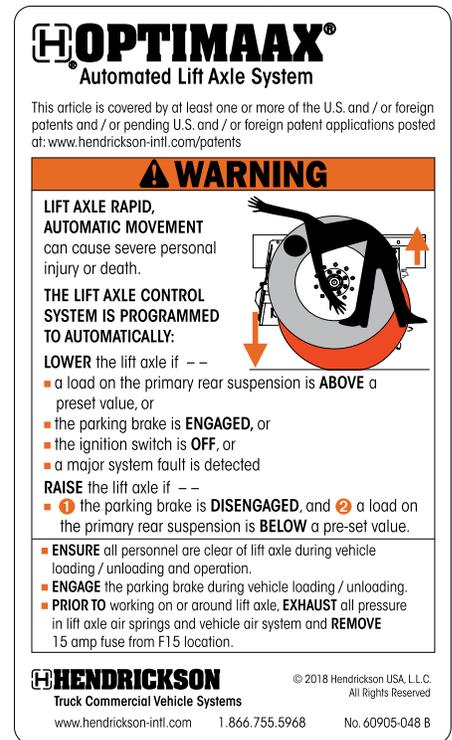
FIGURE 3-1 Product / Safety Decal 60905-048

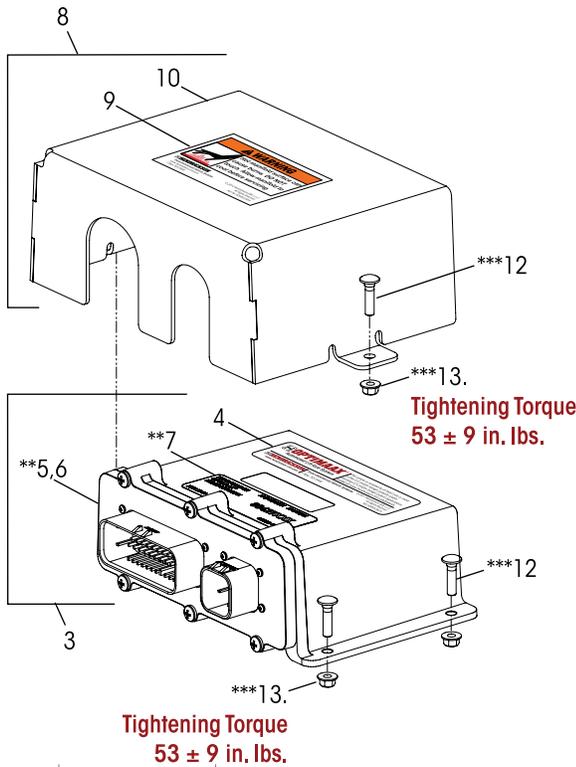
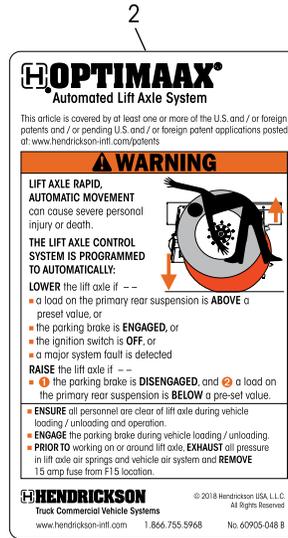
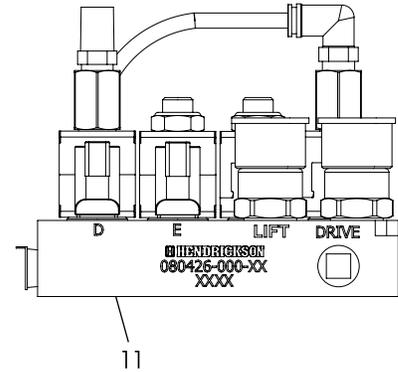
SECTION 5 Parts List

KEY NO.	PART NO.	DESCRIPTION	VEHICLE QUANTITY	TORQUE VALUE
1	093267-OXX	*OPTIMAAX Air Controller Module, Includes Key Nos. 2-3, 8, 11, Replaces 080924-OXX and 080692-OXX	1	
2	060905-051	Warning Decal	2	
3	093265-OXX	Electronic Control Unit (ECU), Includes Key Nos. 4-7 Replaces 080925-OXX and 080427-OXX	1	
4	060905-052	OPTIMAAX ECU Decal (Located on hanger and/or fairing)	1	
5		**ECU Hardware	1	
6		**OPTIMAAX EEPROM	1	
7		**OPTIMAAX Programing Decal	1	
8	080860-000	Splash Shield Assembly, Includes Key Nos. 9-10	1	
9	060905-030	Manifold Heat Warning Decal	1	
10	077276-000	Splash Shield	1	
11	91984-000	Air Controller Manifold	1	
12		***M5 x 16 mm Screw	6	
13		***M5 Flange Hex Nut	6	53 ± 9 in. lbs.

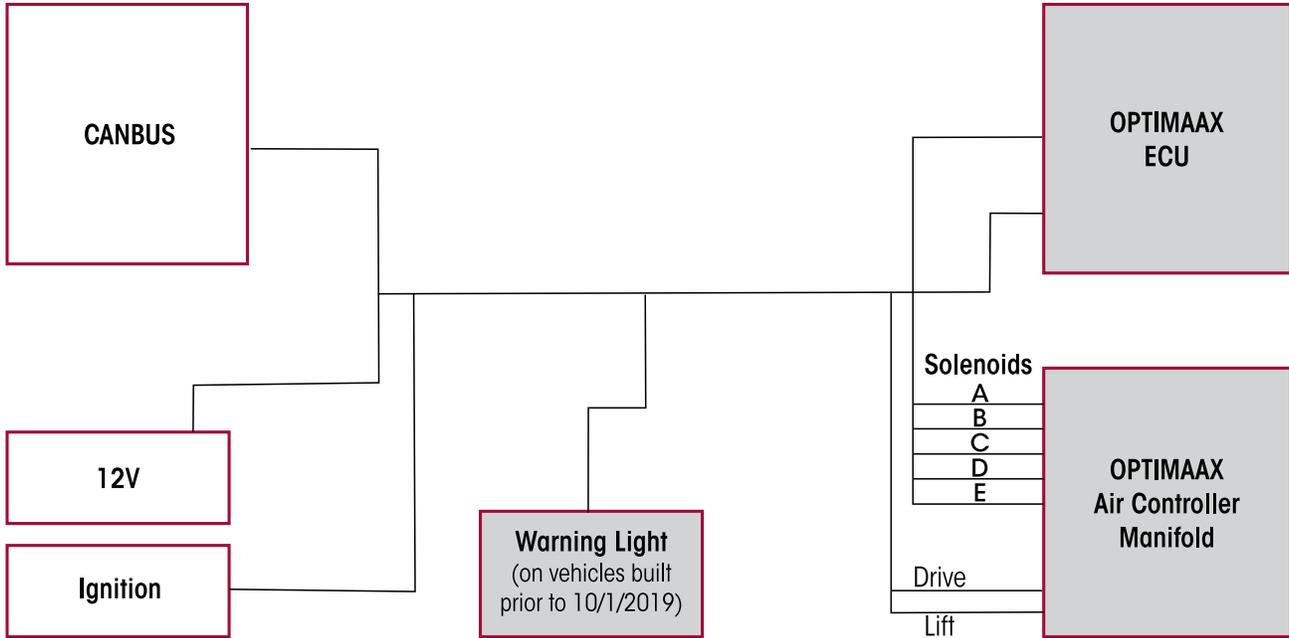
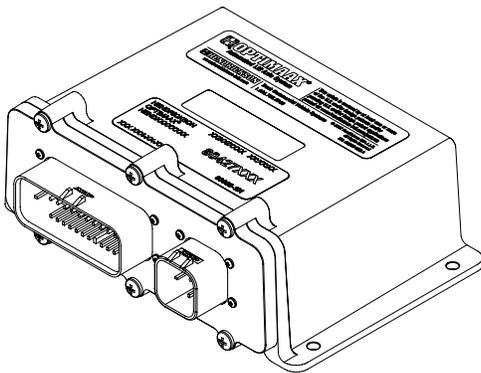
SECTION 7 Wiring Diagram

ELECTRONIC CONTROL UNIT for AIR CONTROLS

6. Ensure the wiring harness is plugged into the ECU and the air controller manifold per the vehicle manufacturer's specifications. Harness connectors have printing (A,B,C,D,E) to indicate which manifold connectors to mate with. The manifold is engraved with matching letters, see Wiring Diagram Section of this publication.

- The wiring harness pressure connector labeled **DRIVE** matches the manifold port engraved **DRIVE**. The harness pressure connector labeled **LIFT** matches with the remaining manifold port.

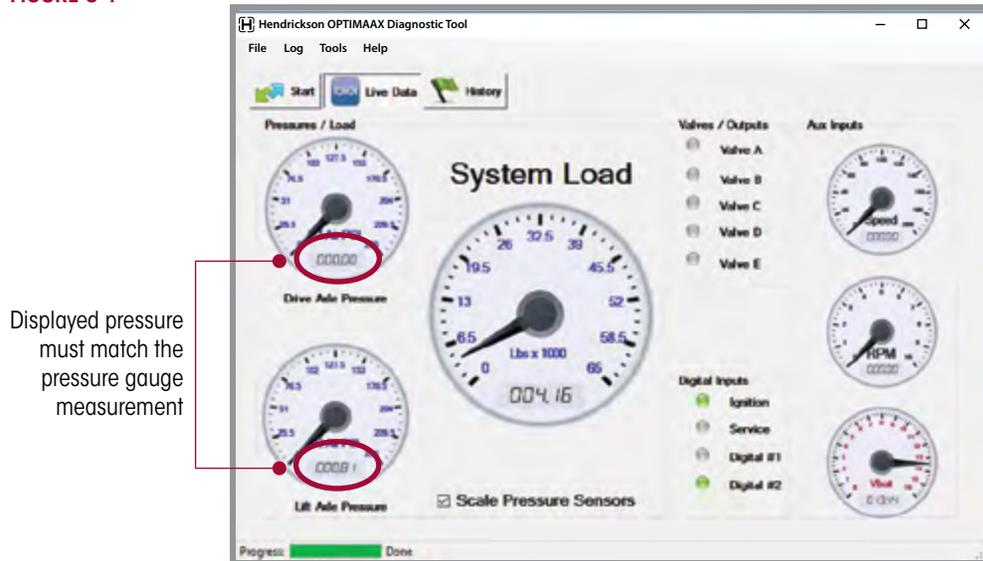
FIGURE 8-1

- **On an annual basis** – calibrate the pressure sensors in the air controller manifold, see Figure 8-1.

1. Connect the Diagnostic Tool Software.
2. With a calibrated pressure gauge apply shop air to the drive port.
3. The displayed pressure in the Diagnostic Tool Software must match pressure gauge measurement within ± 5 PSI. If not, the air controller manifold must be replaced.
4. Repeat Steps 2 and 3 for the lift port.

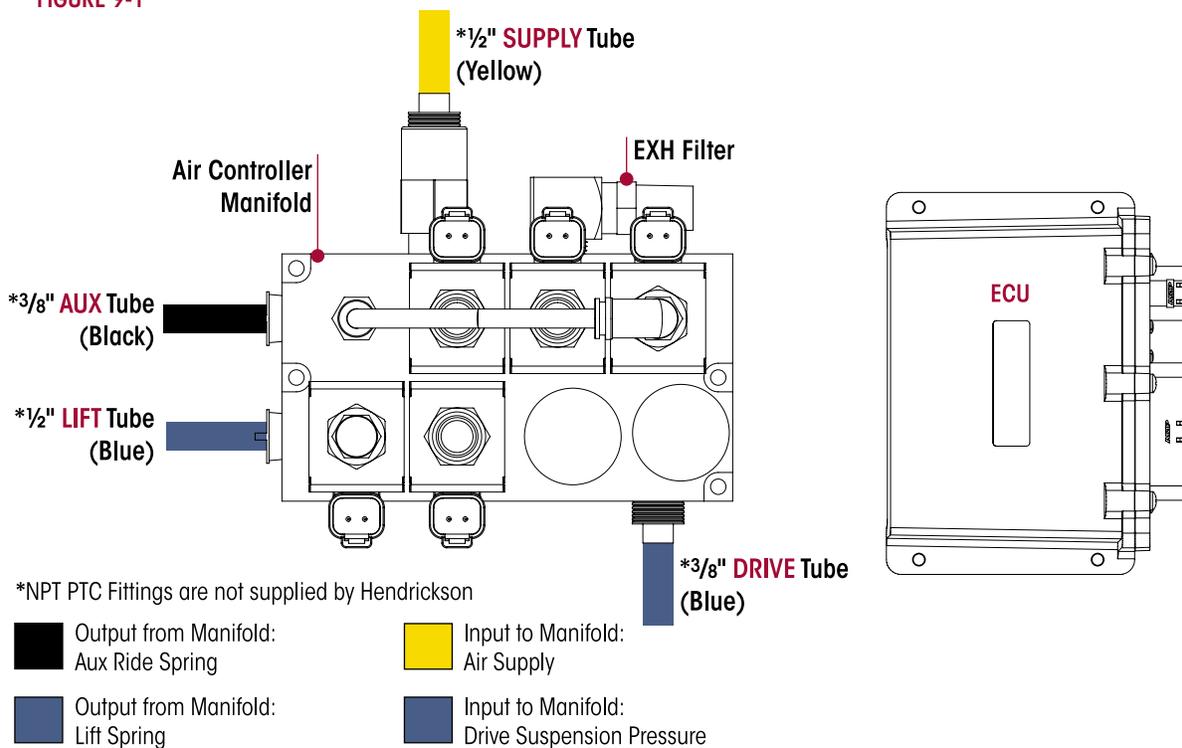
FIGURE 9-1

1. Use only S.A.E. J844 tubing and ensure all tubes are free from kinks.
2. Ensure that the minimum bend radius is achieved on all tubes prior to assembly, see Table 9-1.

3. Use only dedicated tube cutters when preparing tube ends for insertion into push-in fittings.
4. Ensure the tube ends are square, free of damage, and clean.
5. Ensure the tube is fully inserted into the fittings (tube ends are pushed past both the grip ring and the sealing O-ring).
 - SUPPLY and LIFT ½" tubes (not supplied by Hendrickson)
 - AUX and DRIVE ¾" tubes (not supplied by Hendrickson)
6. A spring is used to retain a mesh filter on **DRIVE** and **SUPPLY** ports. These must be retained when PTC fittings are installed (not supplied by Hendrickson). The mesh filter helps to prevent debris from entering the system.
7. Ensure the tubing is not under any tension.

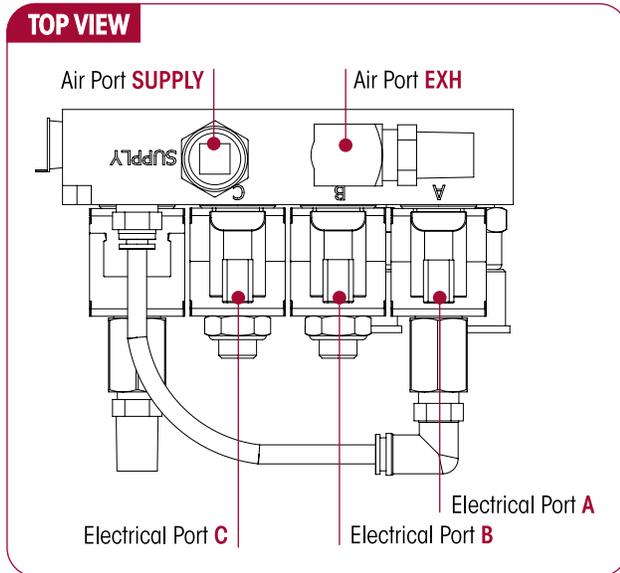
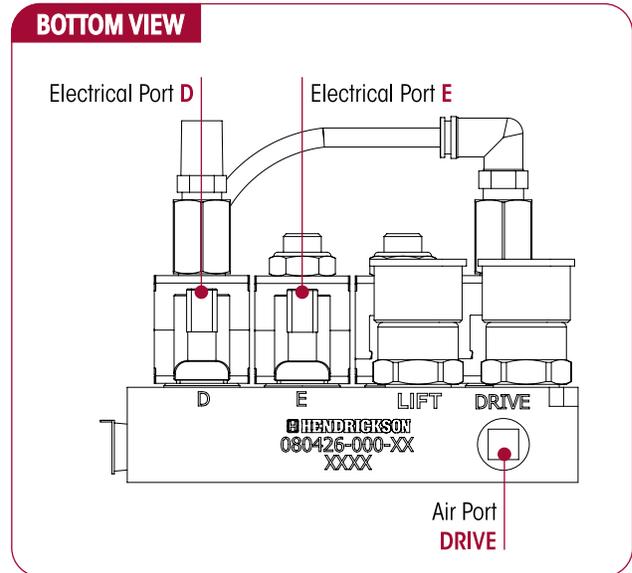
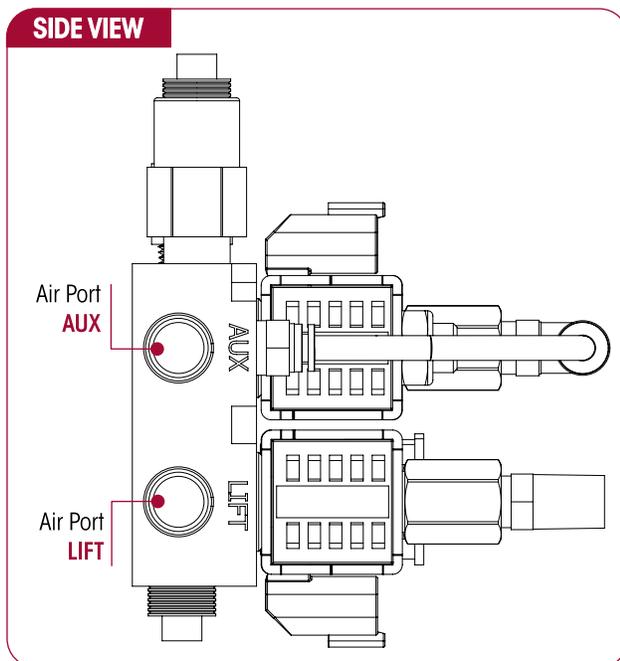
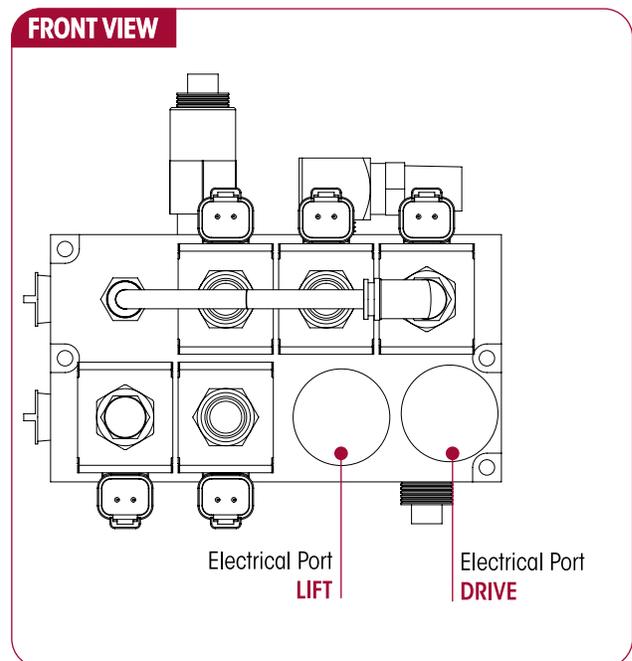
FIGURE 9-2

OPTIMAAX AIR CONTROLLER MANIFOLD
AIR AND ELECTRICAL PORTS

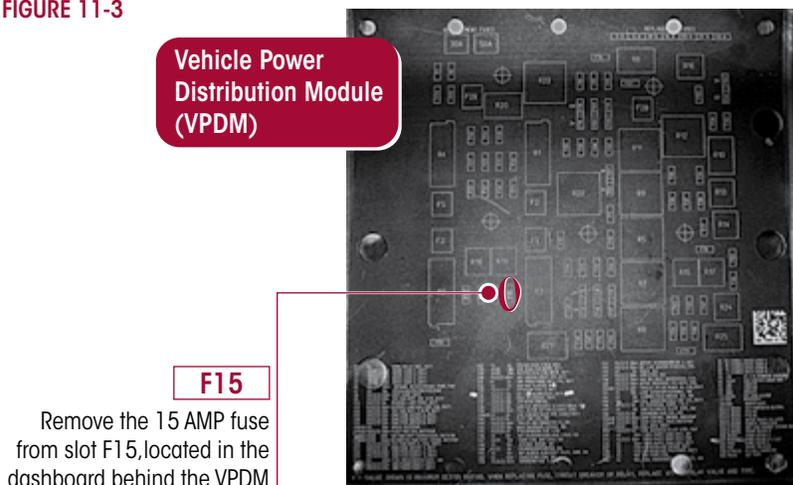
FIGURE 11-3

- Turn ignition off.
- Ensure the lift axle is on ground.
- Remove the 15 AMP fuse from slot F15 located in the dashboard behind the VPDM (vehicle power distribution module), which houses the main fuse and relay center, see Figure 11-3.
- Exhaust all pressure in the lift axle air springs and vehicle air system.

4. Ensure vehicle power is off.
5. Remove the 15 AMP fuse from slot F15 located in the dashboard behind the VPDM (vehicle power distribution module), see Figure 11-3 in System Operation Section of this publication.

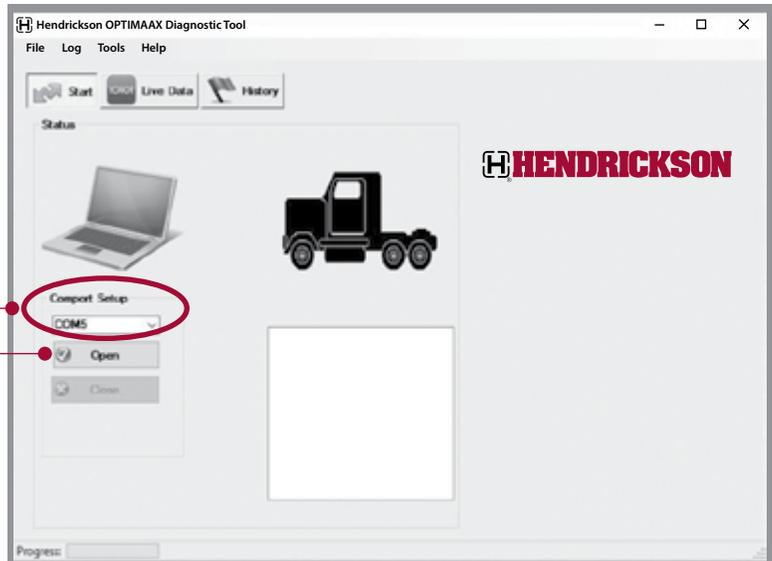
Select a **COM Port** from the pull down menu. There may be more than one com port available.

Pick one, and click **Open**

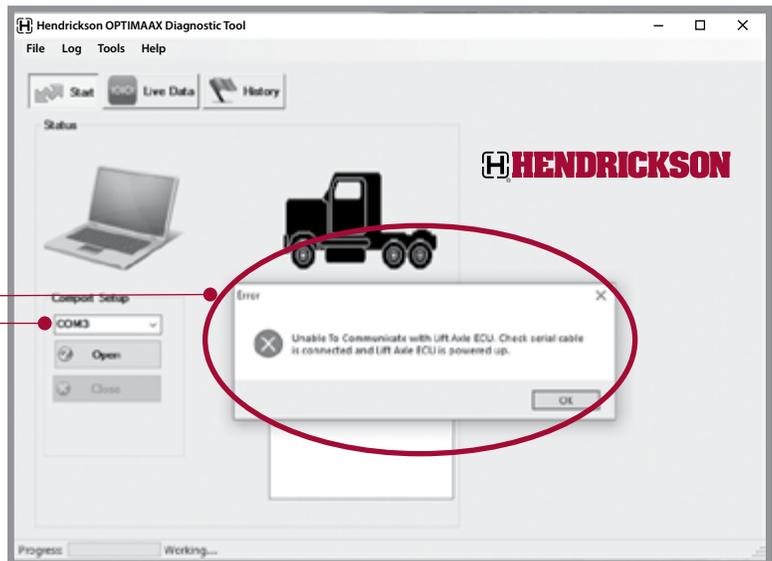
FIGURE 12-3

If the wrong **COM Port** is selected, the software will show an **Error** message

Select another COM Port untill the software opens and select **OK**

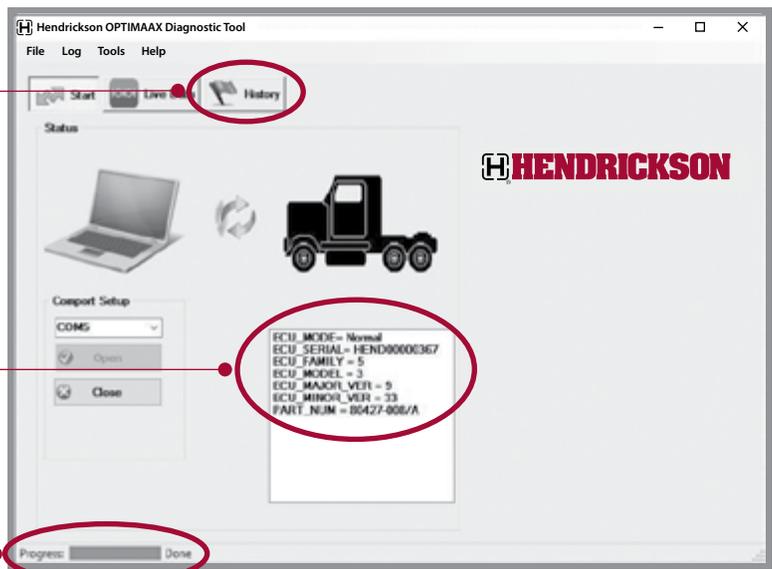
FIGURE 12-4

Click on the **History** tab to view Error / Fault Codes

The screen will look like this when the software is communicating with the controller

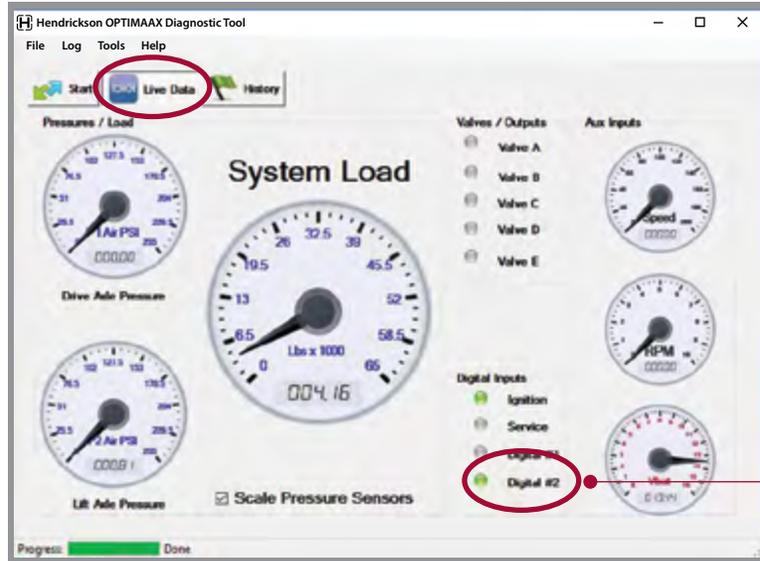
FIGURE 12-5

Digital #2 represents the parking brake signal

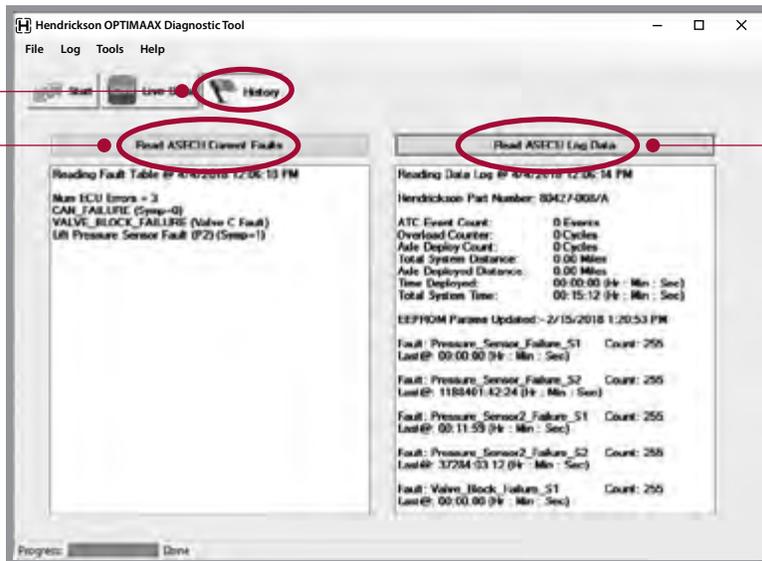
FIGURE 12-6

Click on the **History** tab to view ASECU current Error / Fault Codes

Click here to view ASECU Log Data

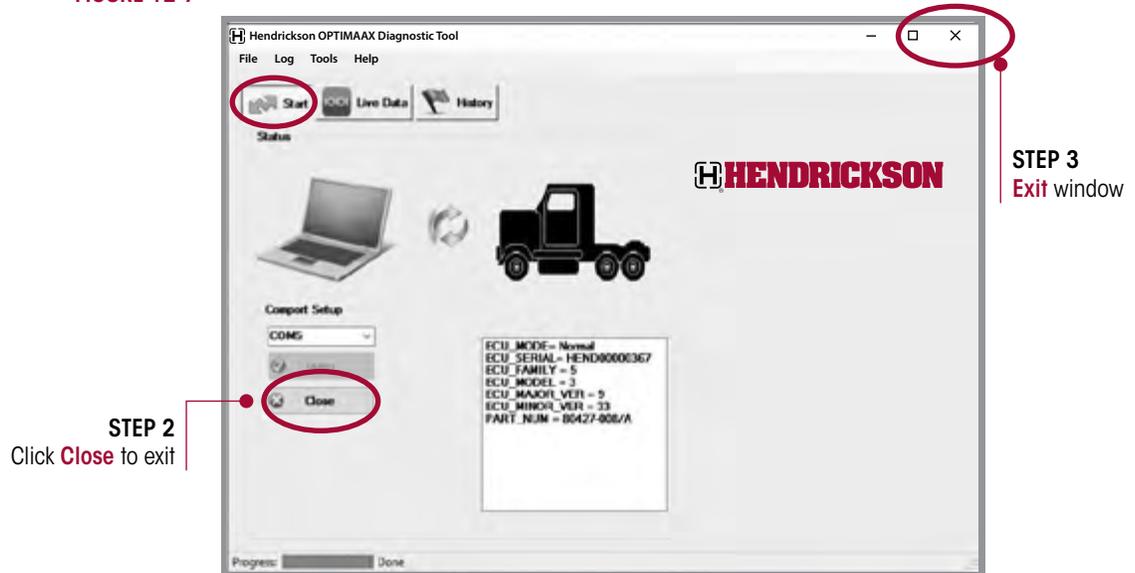
FIGURE 12-7

1. Prior to exiting the Diagnostic Tool Software, **ENGAGE** the parking brake.
2. Press the **CLOSE** button on the **START** tab to terminate communication with the lift axle ECU, see Figure 12-7.
3. **Exit** the window, see Figure 12-7.
