H TECHNICAL PROCEDURE

ULTIMAAX® Rear Suspension for Fire and Rescue Vehicles

SUBJECT: Service Instructions

LIT NO: 17730-299

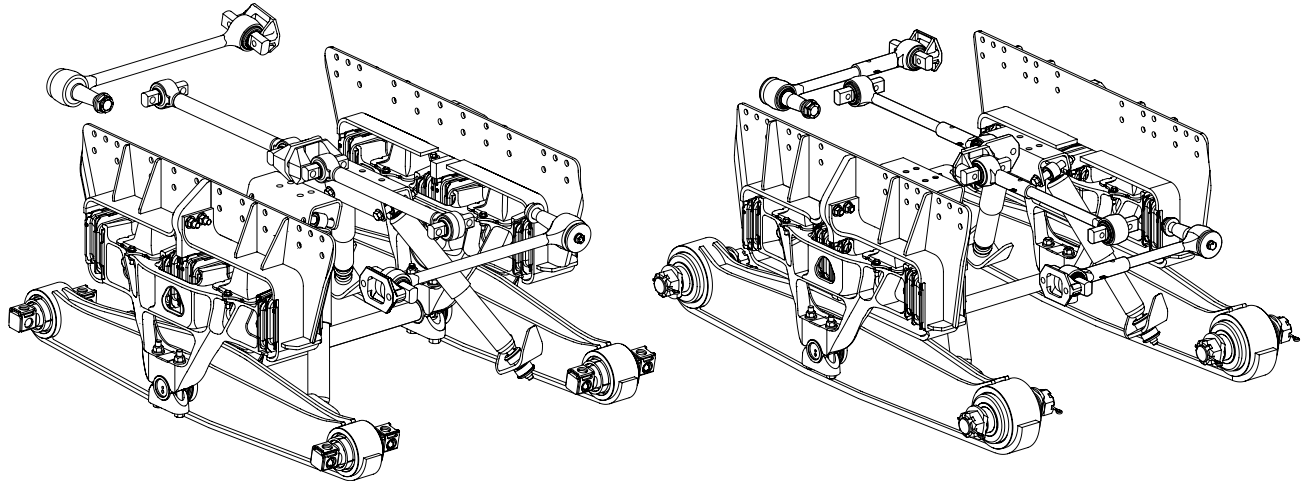
FIGURE 2-1

54K • 58K Capacity
9½" • 10" • 10¼" • 11½" Ride Height

63K Capacity
10" • 10½" Ride Height

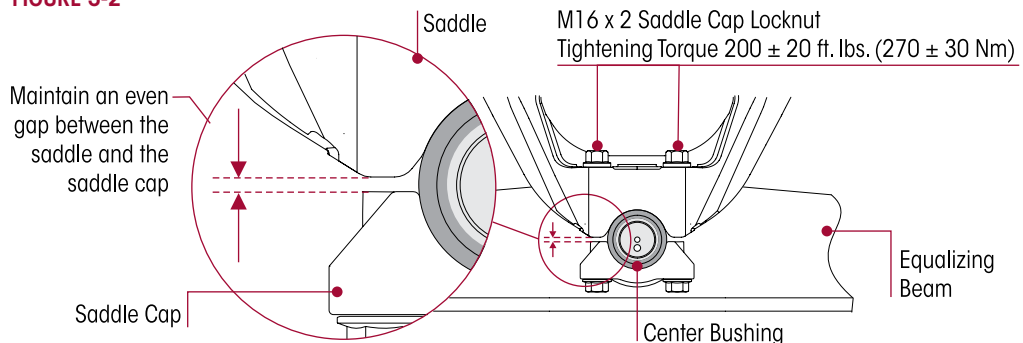
FIGURE 3-2

A SADDLE ASSEMBLY IS ATTACHED TO THE CENTER BUSHING OF EACH EQUALIZING BEAM WITH TWO (2) SADDLE CAPS. EACH SADDLE CAP USES TWO (2) BOLTS TO CLAMP THE CENTER BUSHING INNER METAL TO THE SADDLE. EACH SADDLE CAP MUST BE INSTALLED SO THAT THERE IS AN EVEN GAP BETWEEN THE SADDLE CAP AND THE BASE OF THE SADDLE LEGS AS SHOWN IN FIGURE 3-2. IF EACH SADDLE CAP IS NOT INSTALLED EVENLY, THE SADDLE LEGS COULD BECOME DEFORMED, RESULTING IN BENT BOLTS OR DAMAGED SADDLES.

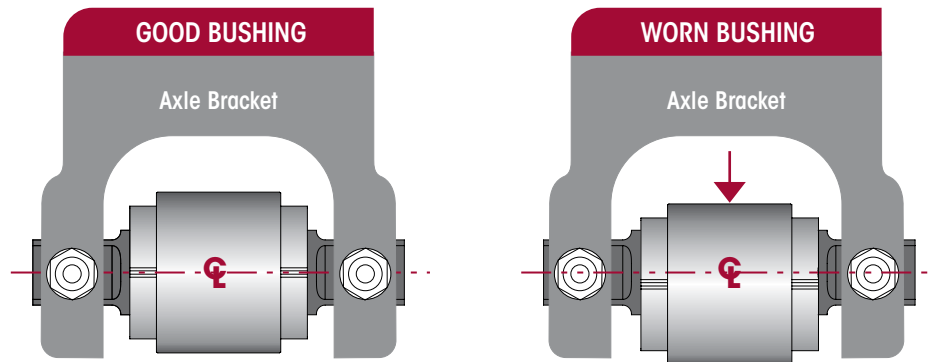
FIGURE 6-3

A **GOOD** bushing will result in the equalizing beam end hub appearing to be **centered** with the centerline of the end bushing in the axle bracket

A **WORN** bushing will result in the equalizing beam end hub appearing to be **5/8" (15 mm) offset/below** the centerline of the end bushing in the axle bracket

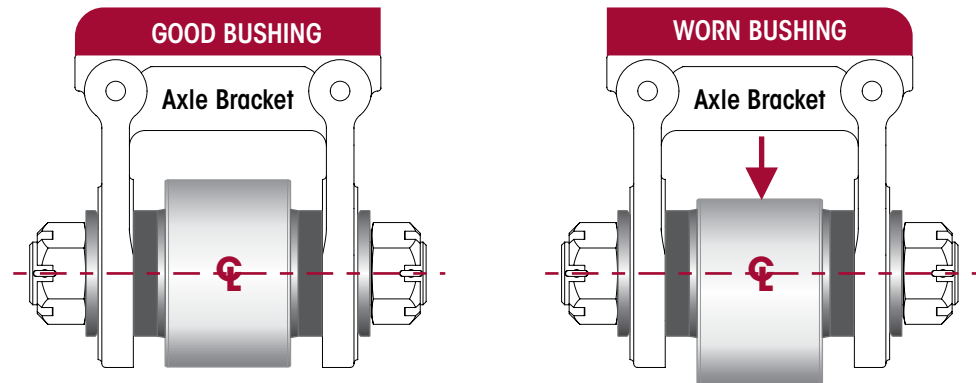
FIGURE 6-6

A **GOOD** bushing will result in the equalizing beam end hub appearing to be **centered** with the centerline of the end bushing in the axle bracket

A **WORN** bushing will result in the equalizing beam end hub appearing to be $\frac{5}{8}$ " (15 mm) **offset/below** the centerline of the end bushing in the axle bracket

1. Check the wheels.
2. Visually inspect suspension components for signs of movement or excessive wear.
 - Inspect the equalizing beam end connection for signs of excessive wear or looseness.
 - Look for worn, frayed or distorted rubber in the beam, see Figure 6-6.

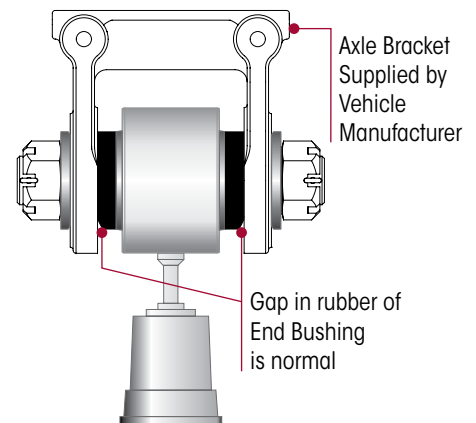
FIGURE 6-8

- Place a jack under each beam end as shown. Raise the jack to check for movement in the connection or rubber components, see Figure 6-8.

The gap at each side of the visible rubber on the lower part of the bar pin end bushing is normal, see Figure 6-8, and is not an indication to replace the bushing. Because all rubber end bushings are in compression, with the load bearing on the top side, the lower side of the rubber is slightly relieved, allowing the rubber to move inward, and a gap appears.

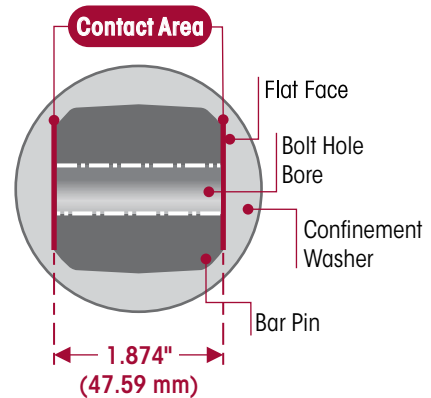
FIGURE 6-10
Shim Type Bar Pin End Bushing

If bar pin measurement is **less than 1.874" (47.59 mm)**, replacement is required.

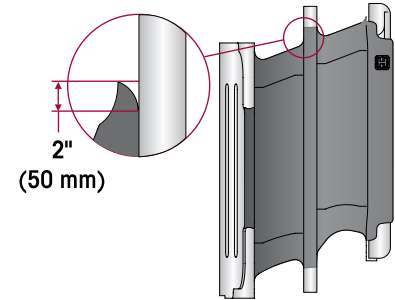
FIGURE 6-18

- Bonding separation of the rubber from any of the bonded rate plate surfaces to a maximum depth of approximately 2" (50 mm) is acceptable, see Figure 6-18. If the bonding separation depth is 2" (50 mm) or more, the shear springs require replacement.
- A certain amount of gradual breakup of the rubber surface is acceptable. Use a feeler gauge to measure cuts or splits in the rubber. If the measurement is over a depth of 2" (50 mm), then the shear springs require replacement, see Figures 6-19 and 6-20.

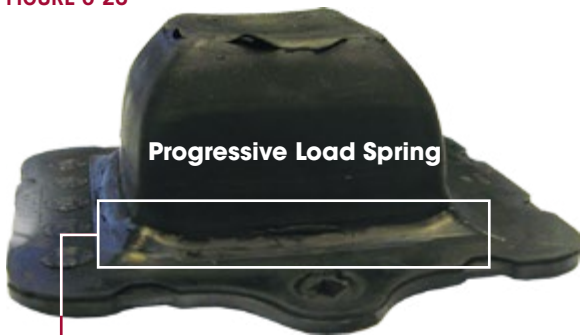
FIGURE 6-23

Polished Appearance — Creases formed by the folding of the rubber surface under load are acceptable.

- If any cuts or splits in the rubber of over 2" (50 mm) in length and an average depth of ½" (13 mm), the effected PLS requires replacement. A certain amount of gradual breakup of the rubber surface is normal. The most probable areas for potential cuts, splits, or wear are shown in Figure 6-22 as "///////".
- The **bonding separation depth** of the rubber from the PLS mounting base plate surface (see Figure 6-22) is more than ½" (13 mm), the effected PLS requires replacement.
- Creases formed by folding of the rubber surface under load are acceptable. These appear as stripes on the surface, polished by wear or covered with tacky rubber, see Figure 6-23.

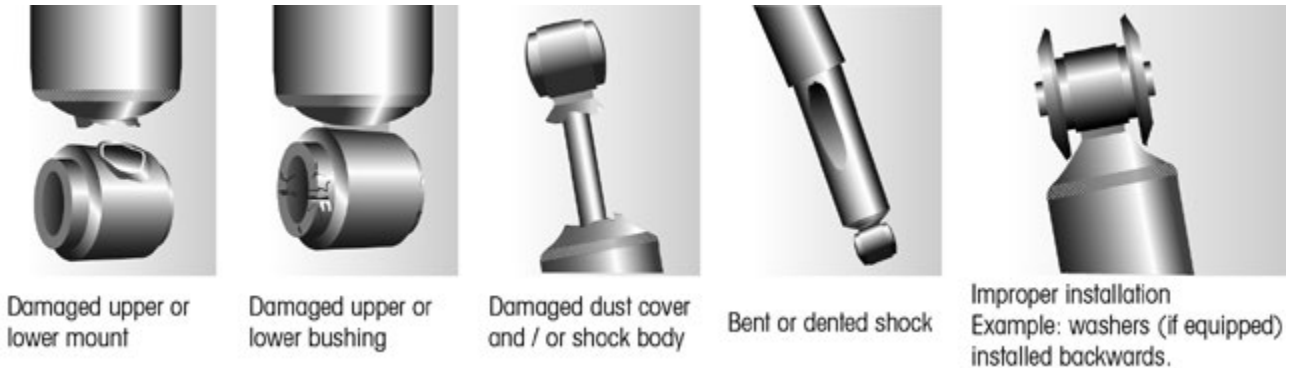
SHOCK ABSORBER VISUAL INSPECTION - UNACCEPTABLE CONDITIONS

The inspection must not be conducted after driving in wet weather or a vehicle wash. Shocks need to be free from water. Many shocks are often misdiagnosed as failures. Misting is the process whereby very small amounts of shock fluid evaporate at a high operating temperature through the upper seal of the shock, see Figure 6-29. When the “mist” reaches the cooler outside air, it condenses and forms a film on the outside of the shock body. Misting is perfectly normal and necessary function of the shock. The fluid, which evaporates through the seal area helps to lubricate and prolong the life of the seal.

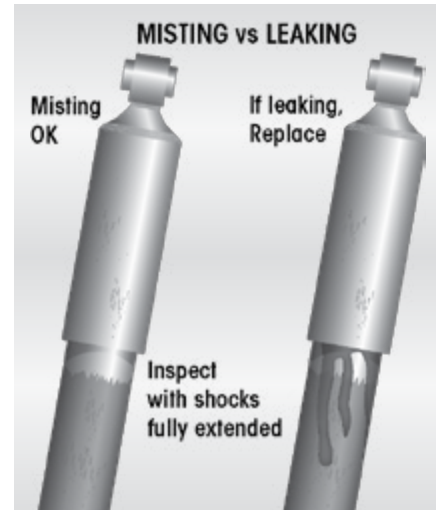
FIGURE 6-29

The ULTIMAAX suspension is equipped with a premium seal on the shock, however this seal will allow for misting to appear on the shock body (misting is not a leak and is considered acceptable).

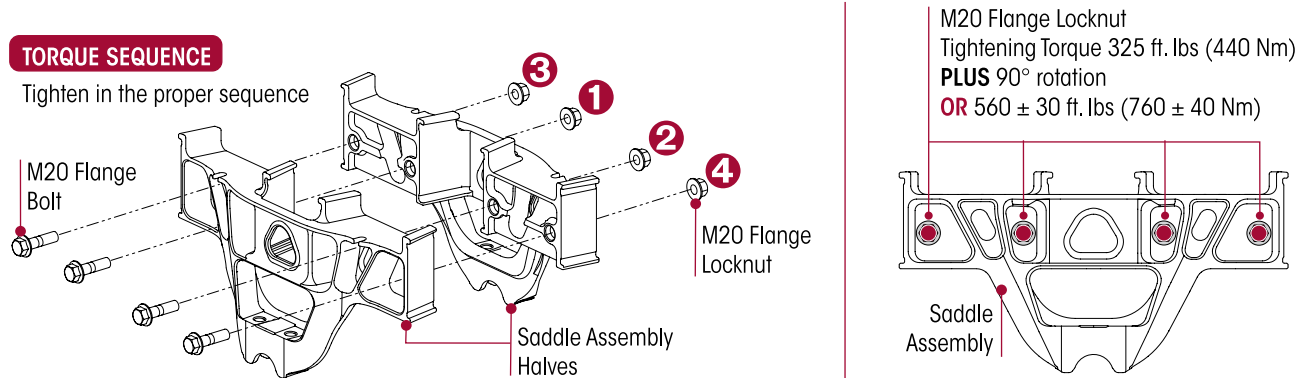
FIGURE 8-12

9. Install the new M20 flange saddle fasteners. Tighten in the proper sequence shown in Figure 8-12 to \mathbb{N} 325 foot pounds plus a 90° rotation, or 560 ± 30 foot pounds torque.
10. Remove temporary tape from the shear springs if used during assembly.
11. Remove each of the saddle assembly tools.
12. Install the progressive load springs (PLS).
13. Install the progressive load spring M10 flange fasteners. Tighten to \mathbb{N} 30 ± 2 foot pounds torque.
14. Remove the frame supports.
15. Lower the frame of the vehicle while engaging the saddles on the equalizing beam's center bushings, see Figure 8-13.

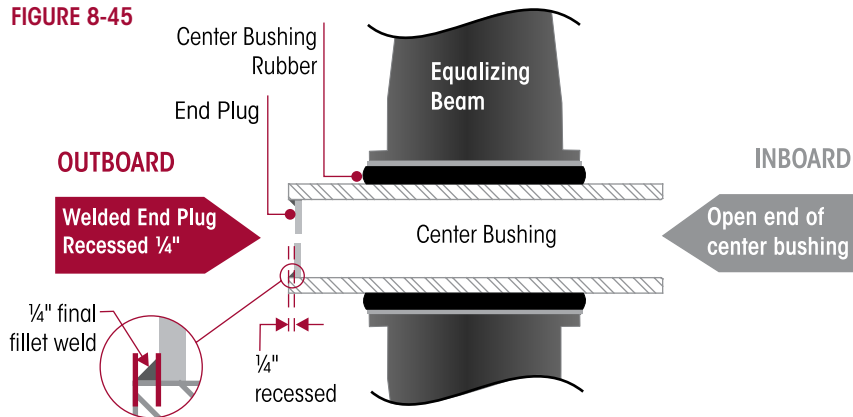
4. Position the end plug 1/4" recessed in the center bushings and tack weld, see Figure 8-45.
5. Check end plug position, final weld shall be a 1/4" fillet, see Figure 8-45.
