H TECHNICAL PROCEDURE

OPTIMAAX® Liftable Forward Tandem Axle and Suspension System for Freightliner Vehicles

SUBJECT: Service Instructions

LIT NO: 17730-309

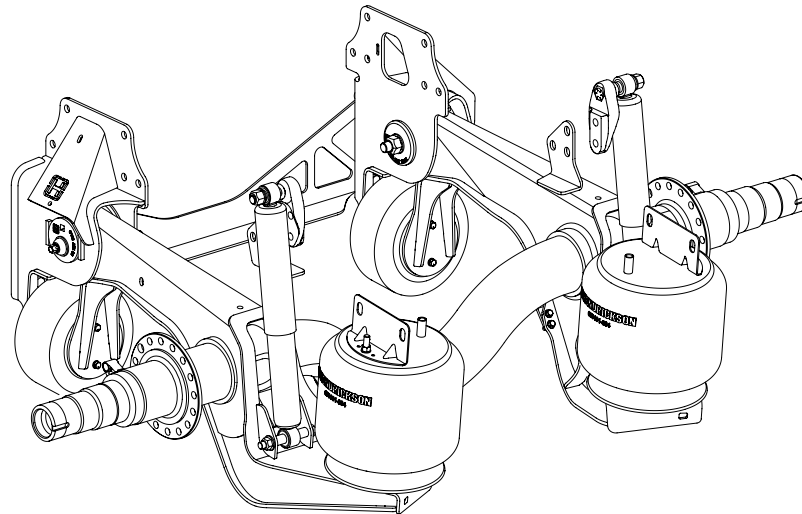
FIGURE 2-1

Hendrickson's OPTIMAAX® liftable forward tandem axle and suspension system is a 6×2 solution to help fleets save fuel cost and weight with comparable handling to 6×4 tandem axle configurations. Operating as a liftable axle in the forward tandem position, this system provides versatility for fleets with variable loads.

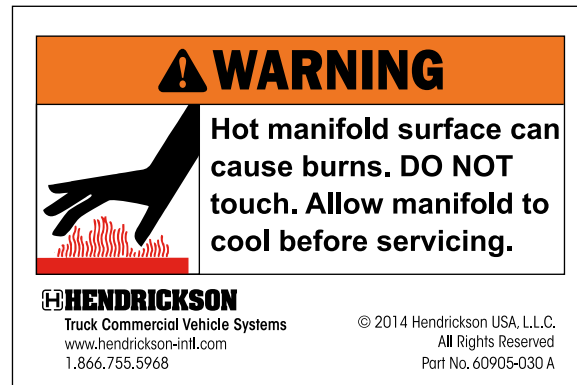
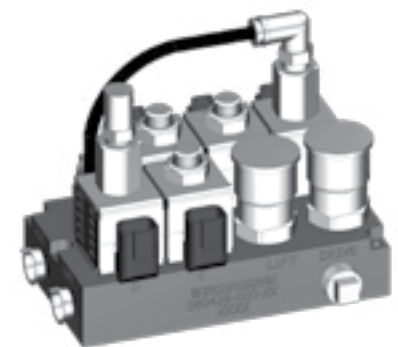
FIGURE 3-2

HOT AIR CONTROLLER MANIFOLD SURFACE CAN CAUSE BURNS. DO NOT TOUCH. ALLOW MANIFOLD TO COOL BEFORE SERVICING, SEE FIGURES 3-2 AND 3-3.

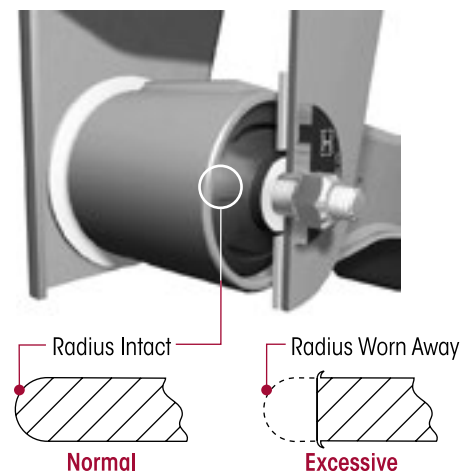
FIGURE 6-2

Missing metal, where the axle beam assembly end hub's radius edge has been worn away is considered excessive. Determine how much wear has occurred, see Figure 6-2.

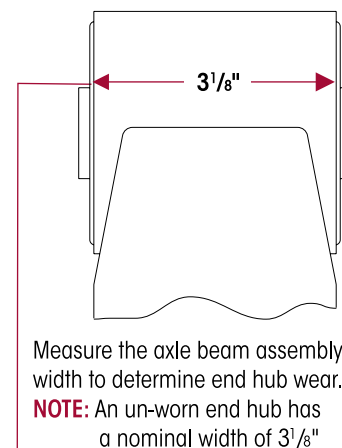
FIGURE 6-3

The axle beam assembly end hub width when new has a nominal width of 3 1/8", see Figure 6-3. The amount of axle beam assembly end hub wear can be determined by measuring the width of the axle beam assembly end hub and subtracting this measured dimension from the new end hub width. If dimension is less than 3 3/32" replacement is necessary, see Table 6-1.

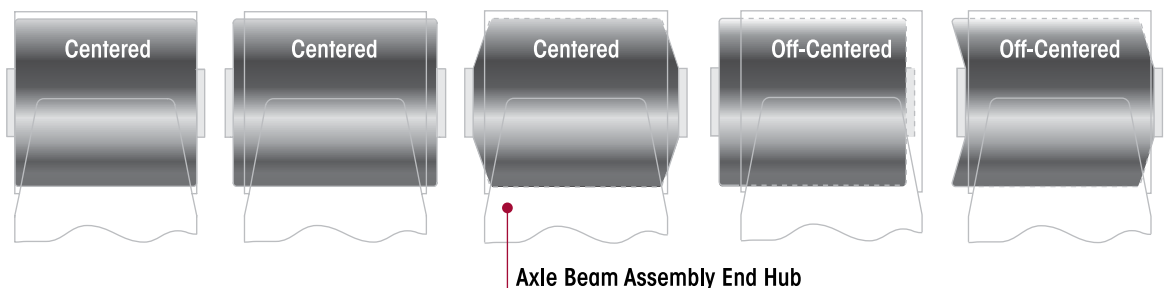
FIGURE 6-8

For evaluation purposes, the TRI-FUNCTIONAL bushing is considered either centered or off-center with respect to the axle beam assembly end hub and considered off-center when a portion of it extends outside of the axle beam assembly end hub on one side and not on the other, see Figure 6-8 for typical examples.

TRI-FUNCTIONAL bushing position examples relative to the axle beam assembly end hub

The key to identifying an off-center TRI-FUNCTIONAL III bushing is the thrust washers. If the thrust washers are in serviceable condition (not missing, cut, worn-through or otherwise deteriorated), the bushing cannot be off-center. However, if an axle beam assembly end hub thrust washer spacer is worn-through, the potential exists for an off-center condition (as described above).

If the TRI-FUNCTIONAL bushing is off-center, but the axle beam assembly end hub width is acceptable, replace the bushing. Refer to TRI-FUNCTIONAL Bushing in the Component Replacement Section of this publication.

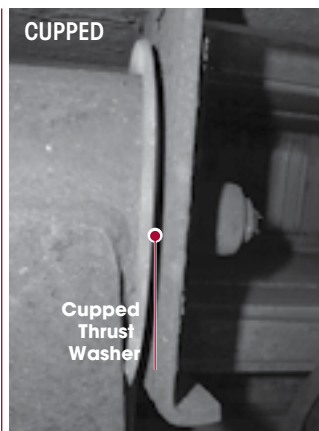
FIGURE 6-11
ACCEPTABLE CONDITION

Cupped Thrust Washer

Friction generated heat can cause the thrust washer to cup around the axle beam assembly end hub. This is acceptable as long as the thrust washer remains intact and is not cut or worn-through.

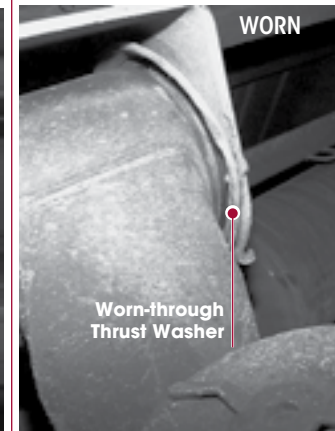
FIGURE 6-12
UNACCEPTABLE

Worn Thrust Washer

The thrust washer shows extreme wear. The thrust washer circumference is completely trimmed by the axle beam assembly end hub. Replacement required.

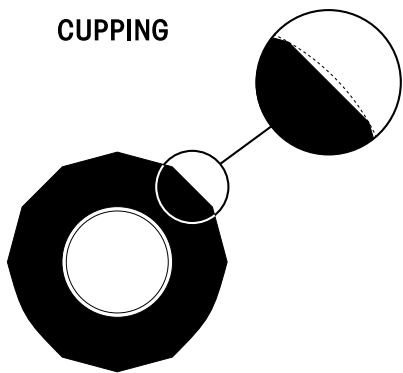
FIGURE 6-15

CUPPING

Cupping — Localized, dished out areas of fast wear creating a scalloped appearance around the tire. Cupping, which appears around the tire on the shoulder ribs, may also progress to adjoining ribs, see TMC RP 219A publication, page 7.

Cupping is usually a result of moderate-to-severe imbalance, improper rim / wheel mounting, excessive wheel end play or other assembly non-uniformity. It can also be due to lack of shock absorber control on some suspension types.

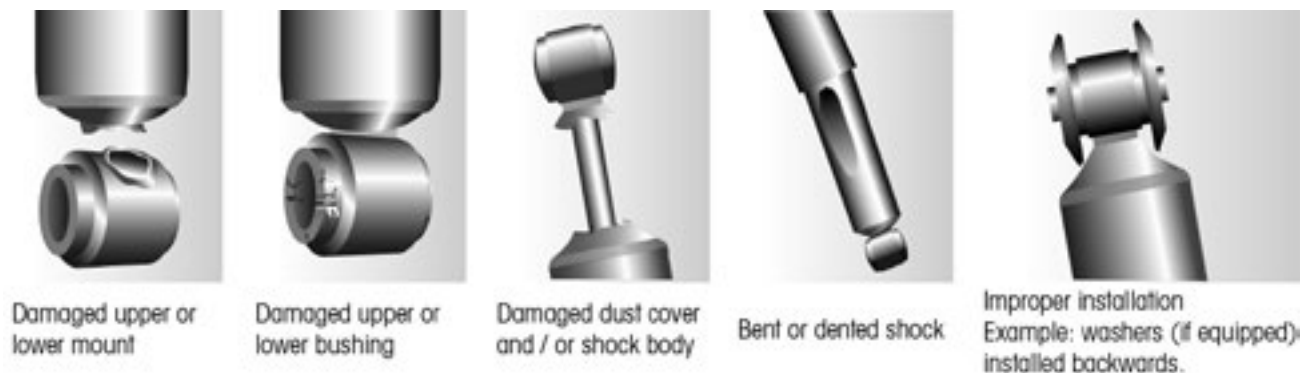
SHOCK ABSORBER VISUAL INSPECTION - UNACCEPTABLE CONDITIONS

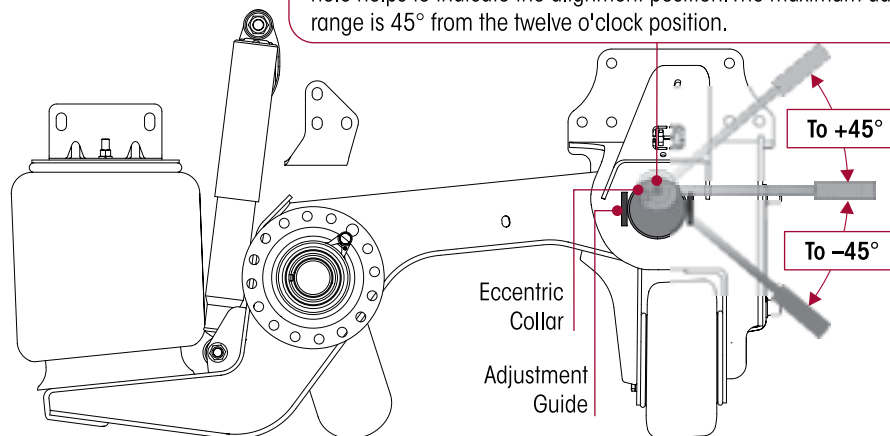
FIGURE 7-2

Rotating the eccentric collar clockwise or counter clockwise provides fore and aft movement of the suspension's axle. The eccentric collar square hole helps to indicate the alignment position. The maximum adjustment range is 45° from the twelve o'clock position.

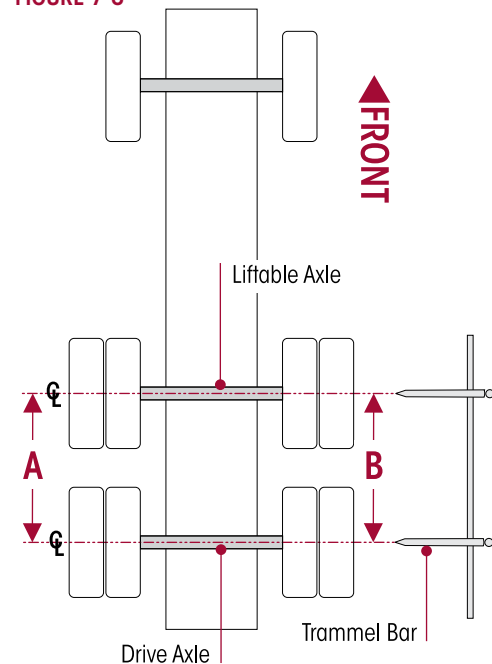
FIGURE 7-3

11. If alignment equipment is not available, Use a trammel bar to measure the distance between the drive axle spindle center to the liftable forward tandem axle spindle center on the left side of the vehicle (**A**), see Figure 7-3.

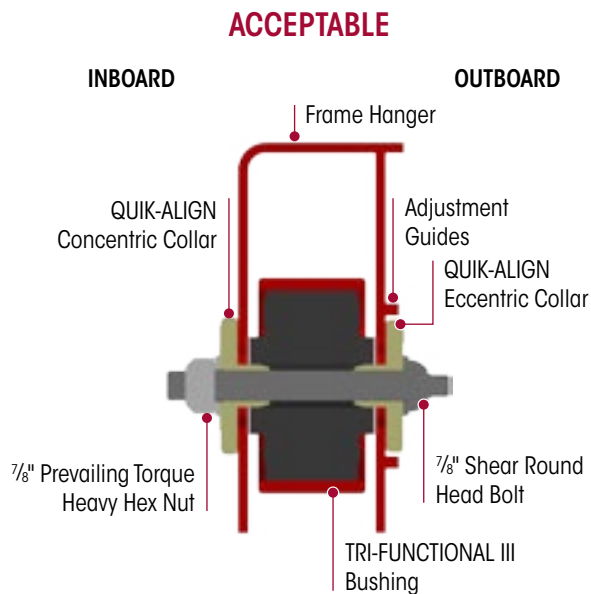
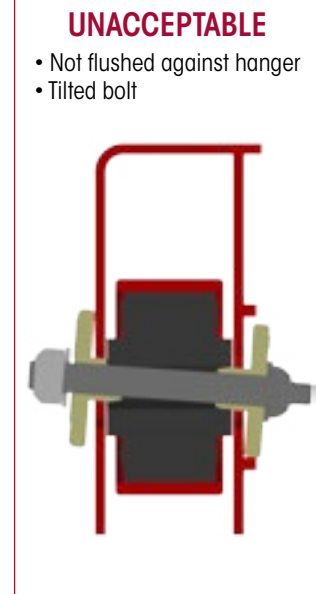
3. Install new QUIK-ALIGN fasteners with the shear round head bolt outboard and the hex nut inboard, see Figure 7-4.
4. Tighten the fasteners tight enough to hold the eccentric flanged collar flush against the hanger face and within the adjustment guide, but loose enough to permit to the eccentric collar to rotate freely, see Figure 7-5.
5. Ensure both the eccentric and concentric collars are flush against the hanger.
6. Use a $\frac{1}{2}$ " square drive breaker bar to rotate the eccentric collar and ensure both the eccentric and concentric collars, are aligned and moving simultaneously, see Figure 7.6.

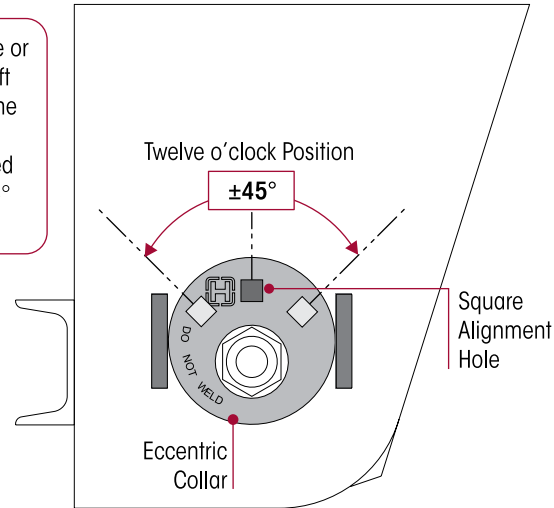
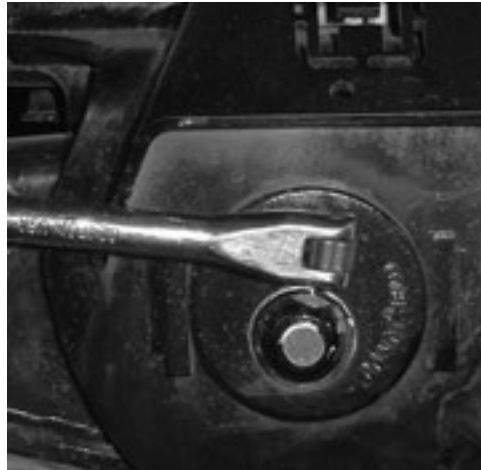
FIGURE 7-7

Rotating the eccentric collar clockwise or counter clockwise provides fore and aft movement of the suspension's axle. The eccentric collar square hole indicates the alignment position. **DO NOT** exceed the maximum adjustment range of 45° from the twelve o'clock position.

- Adjust the axle until the axle is aligned, see Figures 7-7 and 7-8.

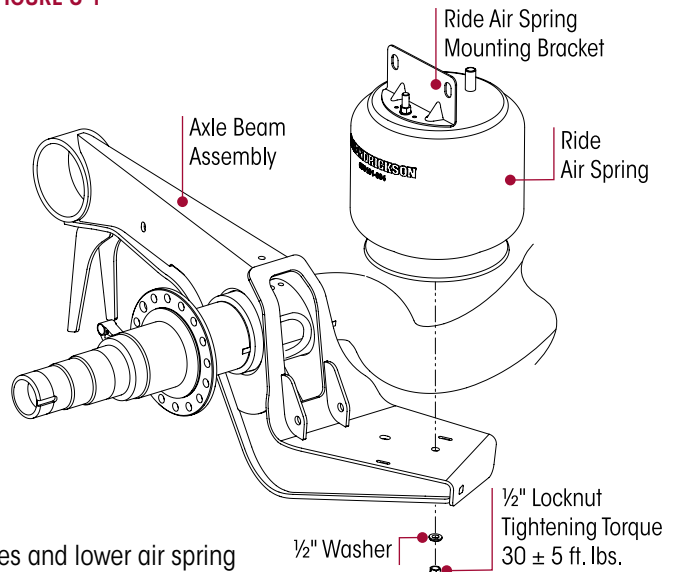
7. Using **HAND TOOLS** only, remove the lower air spring mounting locknut, see Figure 8-1. This will help prevent the air spring mounting stud from breaking during removal.
8. Remove the upper air spring fasteners from the air spring mounting bracket and the frame, see Figure 8-1.
9. Remove the air spring.

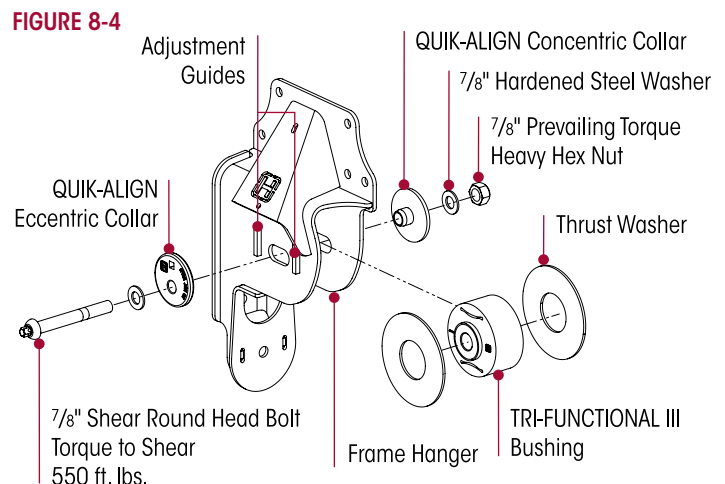
1. Chock the wheels and exhaust the air system.
2. Remove tires.
3. Place a jack under the suspension axle beam assembly.
4. Remove and discard QUIK-ALIGN connection fasteners from the frame hanger, see Figure 8-4.

The QUIK-ALIGN bolt features a round head that helps to prevent reuse. Install the bolt from the outboard side of the frame hanger and tighten with a QUIK-ALIGN socket tool (see Special Tool Section of this publication) until the bolt's round head shears off. To avoid damage to the splines on the shear bolt head, ensure the socket tool fully engages the bolt head.

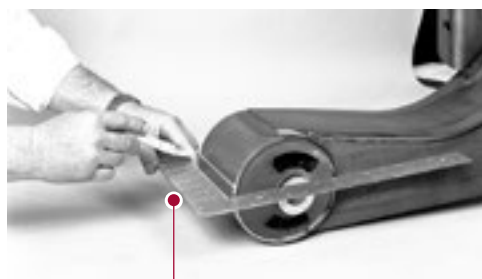
**FIGURE 8-6**

Mark the Bushing Orientation on the Axle Beam Assembly End Hub

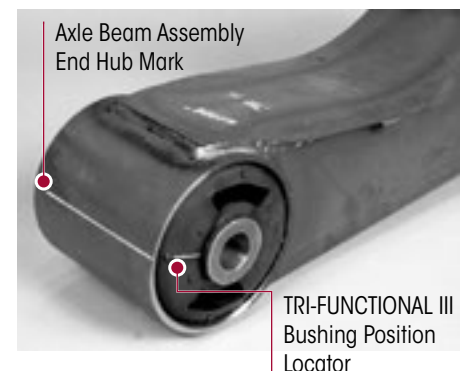
FIGURE 8-7

TRI-FUNCTIONAL III Bushing Position Locator

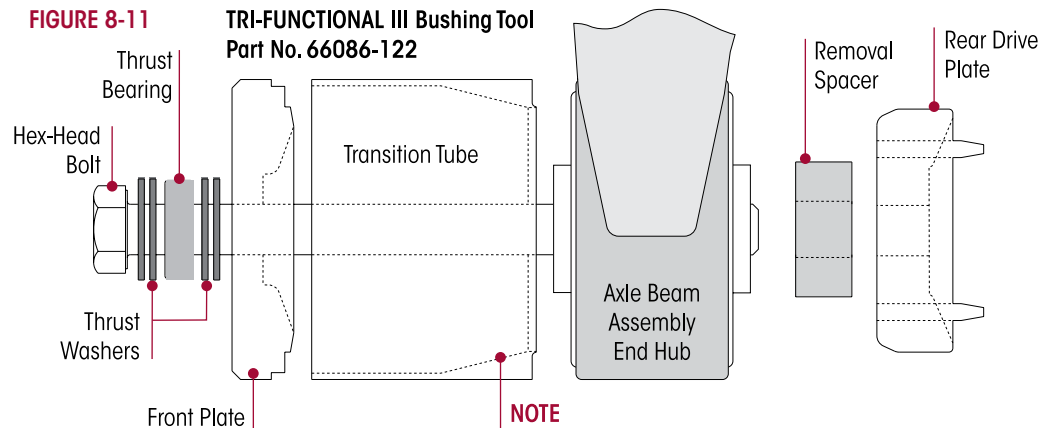
FIGURE 8-11

12. Assemble the TRI-FUNCTIONAL III Bushing Tool, hex-head bolt, washers, tool thrust bearing and front plate, as shown in Figure 8-11.

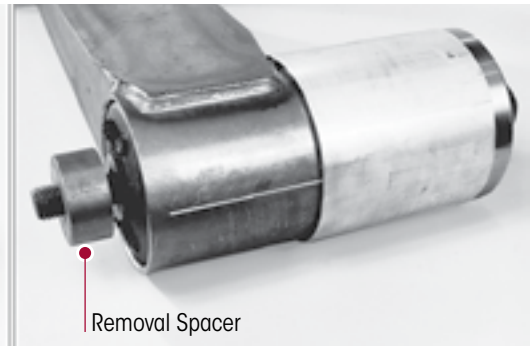
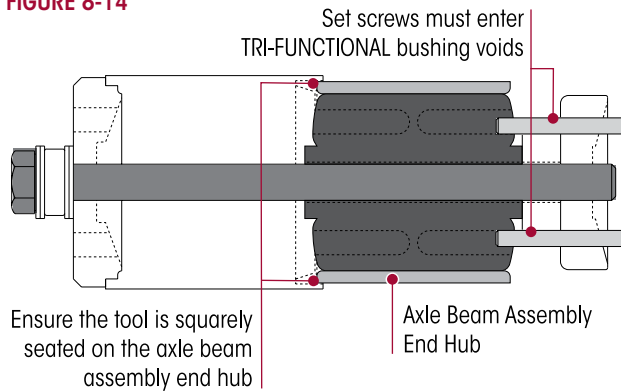
14. Slide the removal spacer over the exposed hex-head bolt threads on the opposite side of the axle beam assembly end hub, see Figure 8-13.
15. Thread the rear drive plate (flat side first) onto the hex-head bolt. The two (2) set screws must enter the bushing voids (open areas) to prevent the rear drive plate from turning, see Figure 8-14.
16. Hand tighten the hex-head bolt until snug. Make sure the tool rests squarely on the axle beam assembly end hub, see Figure 8-14.

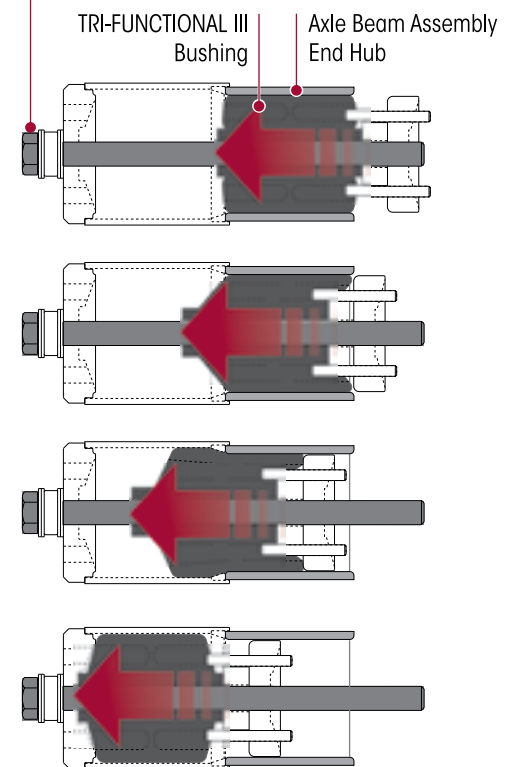
FIGURE 8-16

Turn the tool hex head bolt **clock-wise** to remove the TRI-FUNCTIONAL III bushing from the axle beam assembly end hub

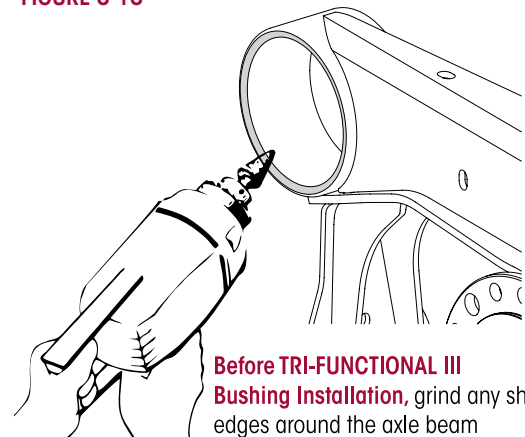
FIGURE 8-18

Before TRI-FUNCTIONAL III Bushing Installation, grind any sharp edges around the axle beam assembly end hub to the radius of minimum 1/8" to maximum 3/16"

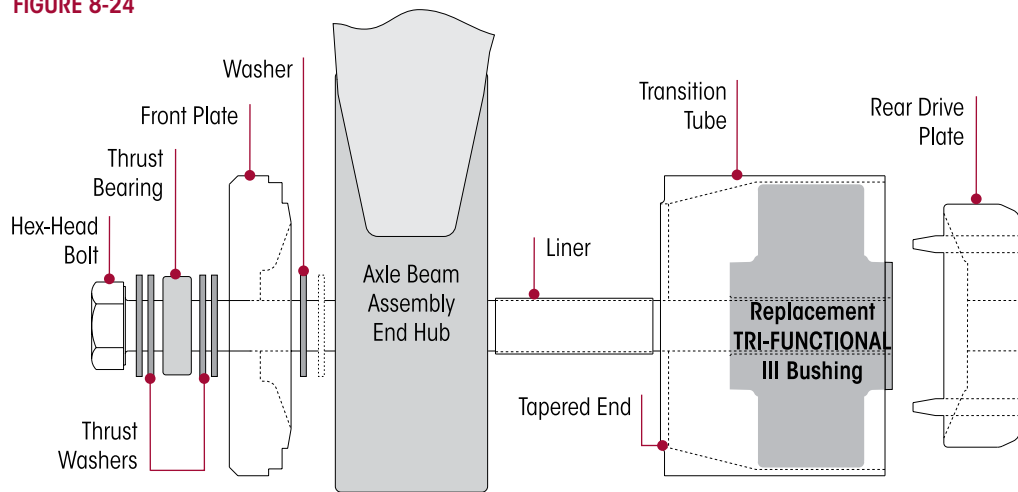
FIGURE 8-24

7. Assemble the TRI-FUNCTIONAL III Bushing Tool, hex-head bolt, washers, tool thrust bearing and front plate, as shown in Figure 8-24. Ensure there are two (2) washers on each side of the thrust bearing, and one (1) washer on the inboard side of the front plate.

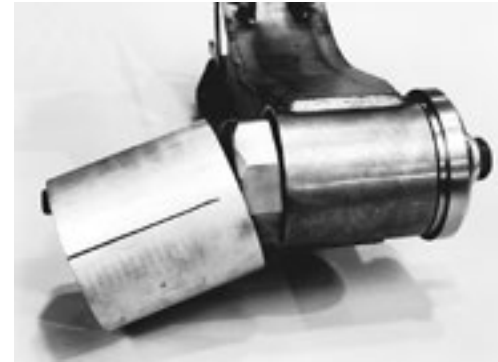
**FIGURE 8-31**

17. Continue to tighten until the hex-head bolt almost stops turning. The transition tube will fall away before the bushing is fully seated in the axle beam assembly end hub and the hex-head bolt stops turning, see Figure 8-31.

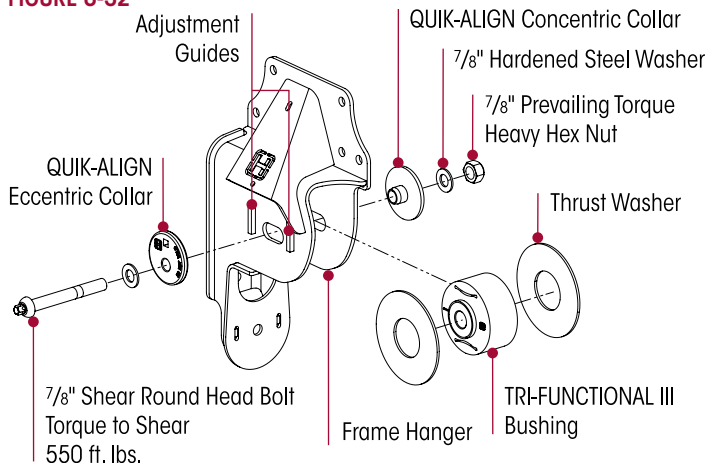
FIGURE 8-32

22. Install the eccentric collar on the outboard side and the concentric collar on the inboard side of the hanger, see Figure 8-32.
